Shimadzu Industrial Systems Co., Ltd.

# Incident Reports and Urgent Safety Notice for Hydrogen-Operated Industrial Furnaces

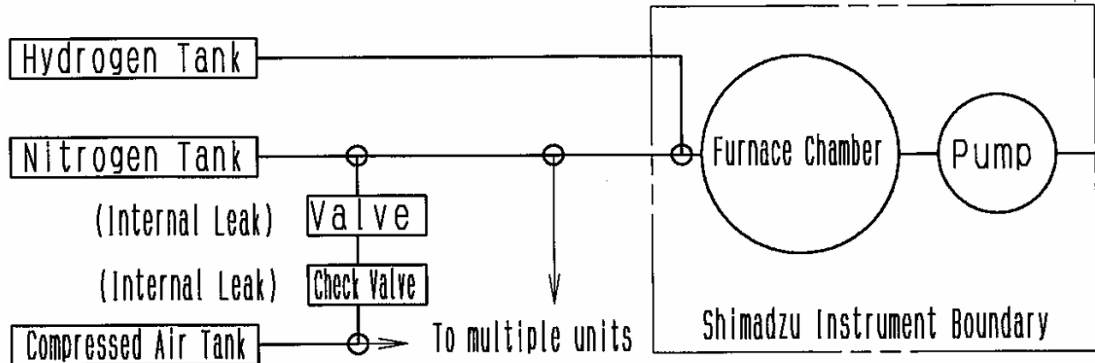
Figure 1. System Schematic at the Time of the Incident

In a hydrogen-operated furnace, the chamber was evacuated and repressurized with nitrogen prior to introducing hydrogen for heat treatment. Upon starting the process, abnormal combustion occurred, causing damage to the internal carbon components.

The customer's compressed air piping and nitrogen piping were physically connected, and internal leakage occurred in a check valve and a valve installed at this connection point. Consequently, the compressed air bled into the nitrogen supply, and the oxygen concentration inside the furnace is presumed to have increased during repressurization.

- (1) Gas piping for nitrogen, compressed air, and hydrogen must be installed as independent lines and connected to their designated ports.**  
**—(Note) Incorrect connections or leaks can result in oxygen contamination or the formation of a flammable atmosphere, causing fire or explosion.**
- (2) Clearly label the gas type, flow direction, and operating pressure range on all gas piping, and perform periodic leak tests.**
- (3) Always perform a leak test (e.g., soap bubble test, leak detector, or pressure hold test) after gas replacement or piping modification.**
- (4) We recommend a purity of 99.99% or higher for the introduced gases.**
- (5) Please consult Shimadzu in advance if modifications to our instrument are required.**

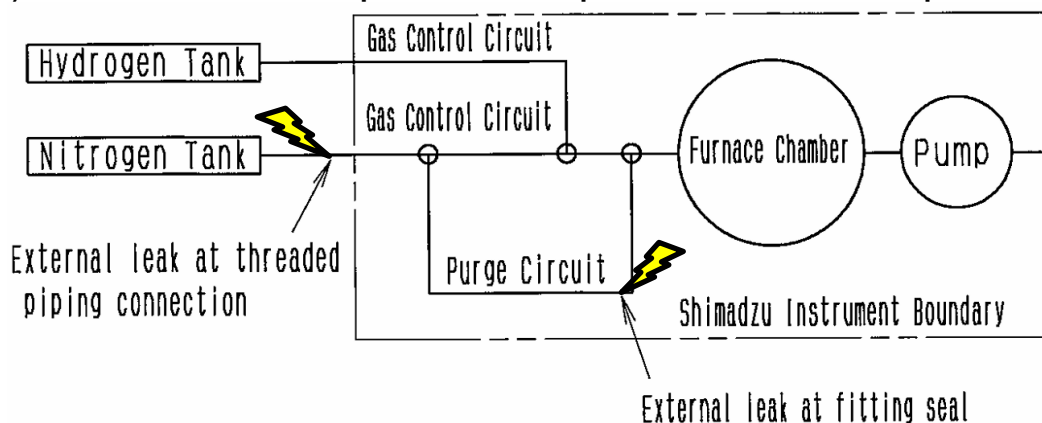
Figure 2. System Schematic at the Time of the Incident

During operation under reduced pressure in a hydrogen-operated industrial furnace, an alarm was triggered, causing the heat treatment cycle to abort. When nitrogen was subsequently introduced to purge the furnace, abnormal combustion occurred, causing damage to the internal carbon components.

An external leak was discovered at the connection point between the customer's nitrogen piping and our supply piping. When nitrogen was introduced while the system was under reduced pressure, the negative pressure generated inside the piping drew in ambient air, which is considered to be the cause. Additionally, the instrument had been relocated, reinstalled, and operated by the customer prior to this incident.

- (1) Please request Shimadzu to perform the relocation and reinstallation of the instrument.
- (2) After gas piping installation, always perform a leak test using methods such as a soap bubble test, a leak detector, or a pressure hold test.
- (3) Establish and execute a periodic leak inspection and maintenance plan.
