Application News

No. A554

Analysis of Stains on Automobile Components Using the AIM-9000 Infrared Microscope

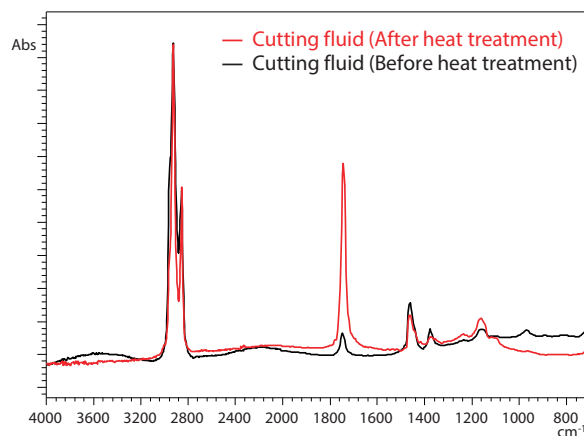
Comparative analysis was performed by measuring cutting fluid and cleaning fluid, both of which can cause stains. We also measured the samples after heat treatment ($150\ ^\circ\text{C}$, 2 hours) in consideration of heat treatment that is performed within the manufacturing process. Fig. 3 and Fig. 4 show the infrared spectra obtained from the cutting fluid and cleaning fluid, respectively, before and after heat treatment. With both the cutting fluid and the cleaning fluid, the infrared spectra changed after heat treatment. In particular, the spectral shape of the cleaning fluid changed greatly since it is water soluble and the heat caused the fluid to dry.

Fig. 3 Infrared Spectra of Cutting Fluid Before and After Heat Treatment

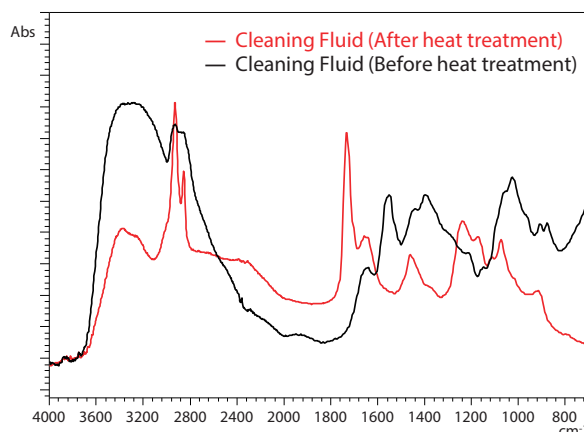
Fig. 4 Infrared Spectra of Cleaning Fluid Before and After Heat Treatment

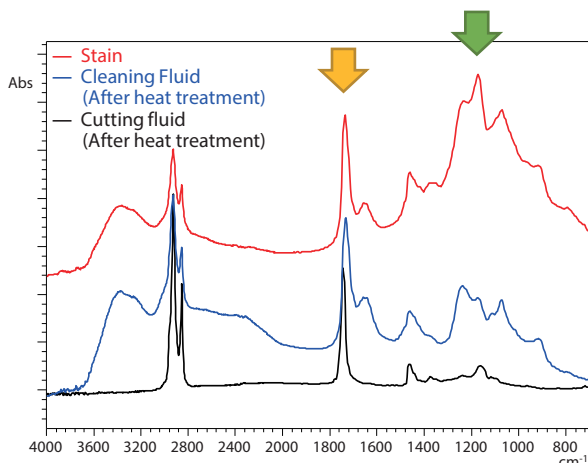
Fig. 5 shows the infrared spectra of the stain and the cutting and cleaning fluids after heat treatment.

Fig. 5 Infrared Spectra of the Stain and the Cutting and Cleaning Fluids after Heat Treatment

The spectral shape of the stain and the heat-treated cleaning fluid show great similarity. Also, by comparing the spectral shape of the stain with that of the cutting fluid, we can see that the peak wavelengths caused by C=O bonds in the vicinity of 1750 cm^{-1} (indicated by the yellow arrow in Fig. 5) differ slightly. We can therefore assume that if the stain were to contain cutting fluid components, the peak of C=O bonds in the spectrum of the stain should expand toward the higher wavelengths or have a shoulder peak. In addition, by comparing the peaks of C-H bonds in the vicinity of 3000 cm^{-1} , we can see that if the stain were to contain cutting fluid components, the peak of C-H bonds in the spectrum of the stain should have a greater intensity than that was observed. From these points, we can consider that the stain does not contain cutting fluid components.

Next, looking at the peak in the vicinity of 1200 cm^{-1} indicated by the green arrow in Fig. 5, this peak is thought to originate from C-O bonds and the intensity of this peak is strong in the spectrum of the stain. This can be considered to be caused by the adherence of a substance other than that of cleaning fluid or by variations in the effects of heat treatment.

From these results, we can conclude that the primary cause of the stain is cleaning fluid that is used in the manufacturing process. In addition, by comparing components before and after heat treatment as in this research, it is possible to narrow down or identify in which process the stain was adhered within the manufacturing process.

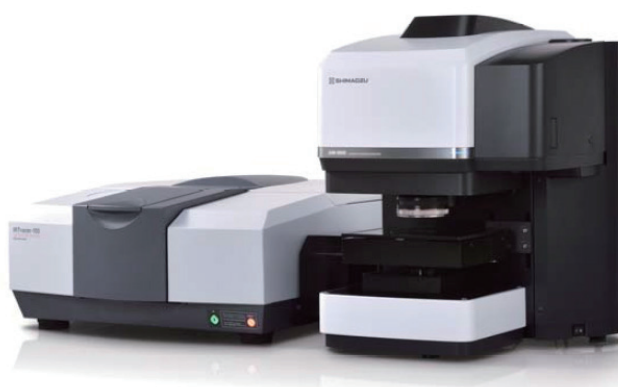
In this research we analyzed a stain that was found in the manufacturing process of an automobile component using the system shown in Fig. 6. Infrared spectroscopy enables easy and rapid measurement and is therefore highly effective in solving issues regarding contaminants. When measuring stains, use of a grazing angle objective (GAO), which is capable of high-sensitivity measurement of organic thin films in the order of nm on the surface of metal plates, may also be effective.

Fig. 6 IRTracer-100 Infrared Spectrophotometer (Left) and AIM-9000 Infrared Microscope (Right)
