Application News

No. X274

Analysis of Food Contaminants by EDX and FTIR – Dental Materials –

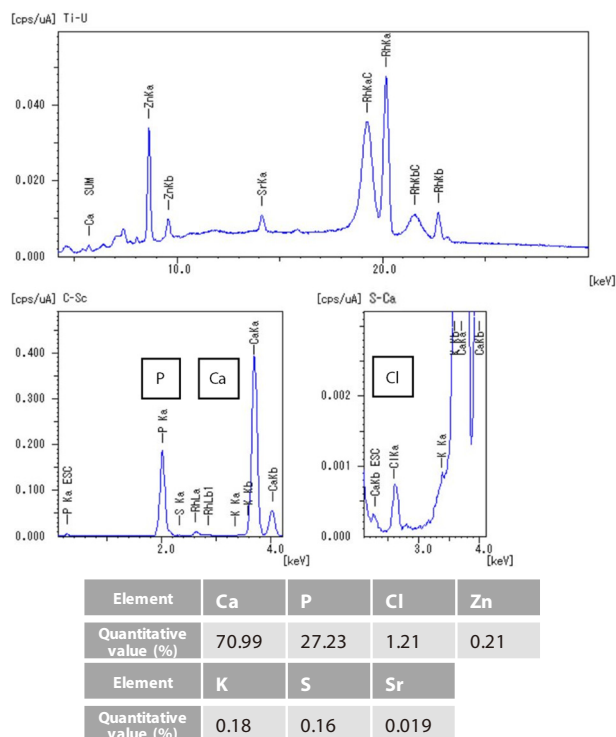
Fig. 1 Photograph of Contaminant (The Yellow Circle is the X-ray Irradiation Range: 1 mmφ)

Fig. 1 shows a photograph of the contaminant, and Fig. 2 shows the results of a ⁶³C-⁹²U qualitative and quantitative analysis by EDX. Ca and P, which are the main components of teeth, could be confirmed. Although the element composition is similar to that of bone, the smaller content of Sr is a distinctive feature of teeth. Fig. 3 shows the results of a qualitative analysis by FTIR. Because the contaminant had a distorted shape and was extremely hard, a small amount of the sample was scraped off and a microscopic transmission measurement was conducted while holding sample in a diamond cell. The main component is calcium phosphate, and peaks originating from proteins can also be confirmed. The proteins are considered to be deposits on the tooth surface. When an adhering deposit exists, the sample is cleaned with water or ethanol, dried, and then measured. However, care is required, as there is a risk of losing the contaminant.

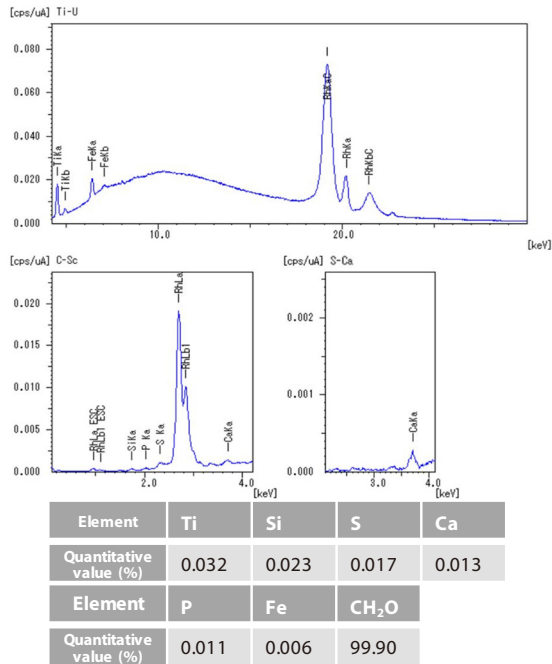
Fig. 4 Photograph of Contaminant (The Yellow Circle is the X-ray Irradiation Range: 1 mmφ)

Fig.4 shows a photograph of the contaminant, and Fig.5 shows the results of a ⁶C-⁹²U qualitative and quantitative analysis by EDX. Because the main component is an organic material, a quantitative calculation was done assuming the balance is CH₂O. Fig. 6 shows the results of a qualitative analysis by FTIR. A small amount of the sample was scraped off and a microscopic transmission measurement was conducted while holding sample in a diamond cell. As the result of a library search, hits were obtained for the spectra of polymethyl methacrylate (PMMA) and polyethyl methacrylate (PEMA). Based on these results, the contaminant is considered to be an artificial tooth (composite resin).

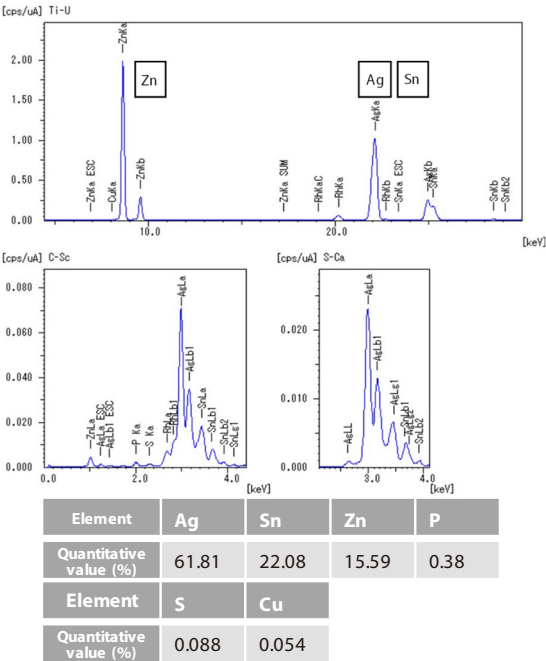
Fig. 7 Photograph of Contaminant (The Yellow Circle is the X-ray Irradiation Range: 1 mmφ)

Fig.7 shows a photograph of the contaminant, and Fig.8 shows the results of a ⁶C-⁹²U qualitative and quantitative analysis by EDX. The main components are Ag, Sn, and Zn. No significant peaks were detected in the FTIR analysis. Based on these results, the contaminant is thought to be an artificial tooth (metal tooth filling = silver crown).
