## Application News

Microfocus X-ray CT System inspeXio™ SMX™-225CT FPD HR Plus

### Example Observation of Corroded Copper Pipe Microfocus X-ray CT System

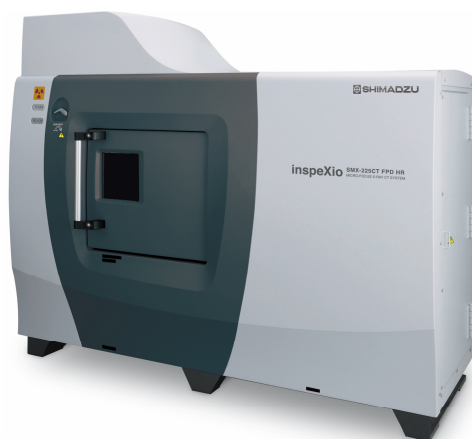
Fig. 1 Microfocus X-ray CT system  
inspeXio™ SMX™-225CT FPD HR Plus

Herein, an example of an observation of a copper pipe corroded with aqueous formic acid solution using a Shimadzu inspeXio SMX-225 CT FPD HR Plus micro focus X-ray CT system (Fig. 1) is described.

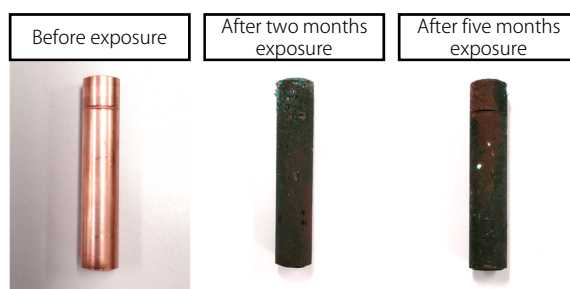
Fig. 2 shows the external appearance of a copper pipe before and after corrosion. The copper pipe has an outer diameter of 8.0 mm, a thickness of 0.8 mm, and a length of 30 mm. A 10 g/L aqueous solution of formic acid is used as the organic acid for corrosion. As shown in Fig. 3, the copper pipe was exposed to formic acid at room temperature by placing a vial containing the copper pipe in a sealed container containing an aqueous formic acid solution. CT scans were performed three times: "before exposure," "after two months exposure," and "after five months exposure".

Fig. 2 External appearance of copper pipe before and after corrosion

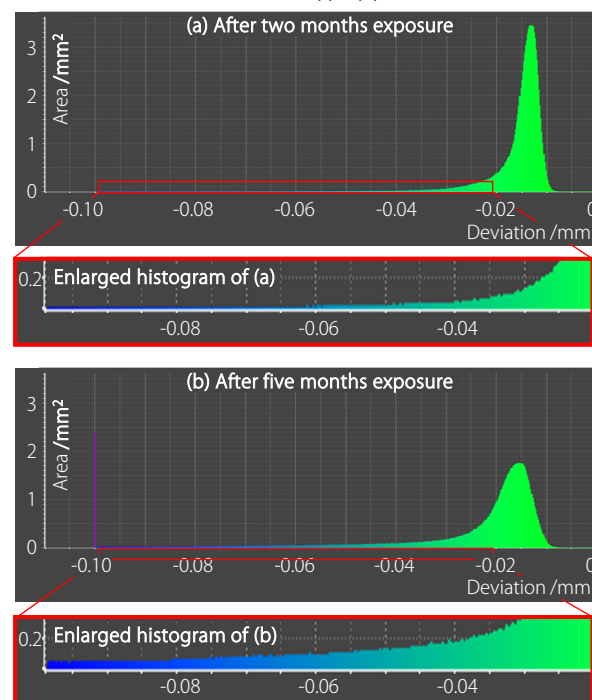
Fig. 7 Example of share analysis: Histogram of the corroded copper pipe

Fig. 6 shows a three-dimensional data comparison for the outer copper pipe surfaces' corrosion state – before and after exposure. Fig. 6a and 6b show the states after two and five months of exposure. The shape deviation of the outer surface of the copper pipe after exposure to that before exposure is color-mapped by superimposing the data before exposure to each data. With increasing exposure period, corrosion progresses; in addition, deep and large dents are observed on the surface. Fig. 7 is a histogram showing the size of the area for each deviation. The relationship between deviation size and color is unified in Figs. 6 and 7. After two months of exposure, we observe an insignificant change; we obtain a large yellow-green area. A significant change is observed after five months of exposure; we observe that the area of blue-green to purple increases with the generation of deep dents, and the histogram spread to the minus side.
