Deterioration Analysis of Automobile Headlight Cover by Plastic Analyzer

This article introduces an example of an analysis of an automobile headlight cover using Plastic Analyzer.

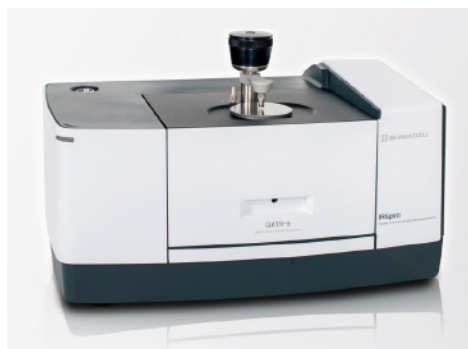
Fig. 1 Plastic Analyzer

Plastic Analyzer is a system comprising an IRSpirit Fourier transform infrared spectrophotometer, a QATR™-S single-reflection ATR measurement accessory, and the Plastic Analyzer Method Package, and is an effective product for contaminant analysis and deterioration analysis (Fig. 1).

- IRSpirit Fourier transform infrared spectrophotometer
- QATR-S single-reflection ATR measurement accessory
- Plastic Analyzer Method Package
 1. UV-damaged plastics library
 2. Thermal-damaged plastics library
 3. Dedicated program/parameters for IR Pilot™

The Method Package is a macro program that includes Shimadzu original UV-damaged plastics library, thermal-damaged plastics library, and the optimum measurement parameters. The attached analysis handbook provides the structural formulas, infrared spectra, and distinctive peak vibration modes for 14 types of plastics.

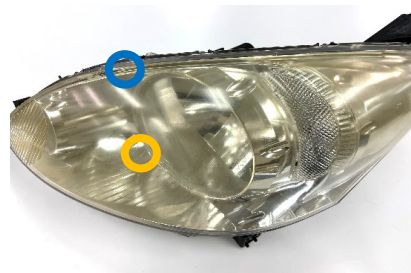
An automotive headlight cover was analyzed. Fig.2 shows a photograph of the measurement specimen. In Fig.2, discoloration or other deterioration of the specimen appearance cannot be seen at the position shown by the blue circle (this position is called the “transparent part”), whereas discoloration due to outdoor exposure can be confirmed at the position indicated by the yellow circle (“yellowed part”), which is near the center of the headlight cover. After cutting out the transparent part by the knife at the edge of the headlight cover and the yellowed part at the center, the surfaces that had been exposed outdoors were analyzed by the ATR method.

Fig. 2 Measurement Specimen
(Yellow Circle: Yellowed Part, Blue Circle: Transparent Part)
