## Application News

# Observation of Joined Metal and Rubber Parts Using a Microfocus X-Ray CT System

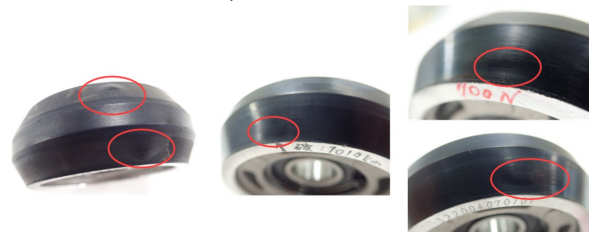
Fig. 3 Workpiece Bulges (Left: 2 Locations on Workpiece A, Center: 1 Location on Workpiece B, and Right: 2 Locations on Workpiece C)

Three types of workpieces were involved, the product that was actually being used (workpiece A) and two types of test samples (workpieces B and C). The rubber material and load test parameter settings for each workpiece are indicated in Table 1. Each workpiece had bulges (Fig. 3).

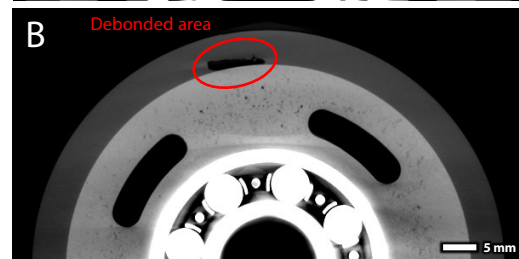
Fig. 7 Rubber Debonding

The overview cross-section images showed internal voids in areas of workpieces A and B that externally appeared normal (Fig. 7). Given the dark gray color of the interior of the bulge, the black color of the void presumably indicates rubber debonding from the metal.
