Application News

Microfocus X-ray CT System inspeXio™ SMX™-225CT FPD HR Plus

Example Observation of Corroded Copper Pipe Microfocus X-ray CT System

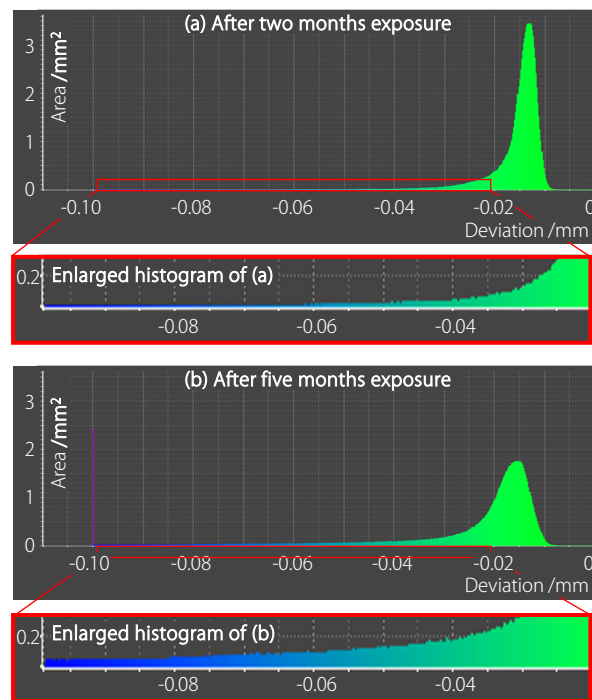
Fig. 7 Example of share analysis: Histogram of the corroded copper pipe

Fig. 6 shows a three-dimensional data comparison for the outer copper pipe surfaces' corrosion state – before and after exposure. Fig. 6a and 6b show the states after two and five months of exposure. The shape deviation of the outer surface of the copper pipe after exposure to that before exposure is color-mapped by superimposing the data before exposure to each data. With increasing exposure period, corrosion progresses; in addition, deep and large dents are observed on the surface. Fig. 7 is a histogram showing the size of the area for each deviation. The relationship between deviation size and color is unified in Figs. 6 and 7. After two months of exposure, we observe an insignificant change; we obtain a large yellow-green area. A significant change is observed after five months of exposure; we observe that the area of blue-green to purple increases with the generation of deep dents, and the histogram spread to the minus side.
