**EPMA-8050G Electron Probe Microanalyzer  
High-Speed Impact Testing Machine**

**Evaluation of Mechanical Characteristics and Fracture  
Surface Observation in Static and High-Speed Tensile  
Tests of Plastic Materials**

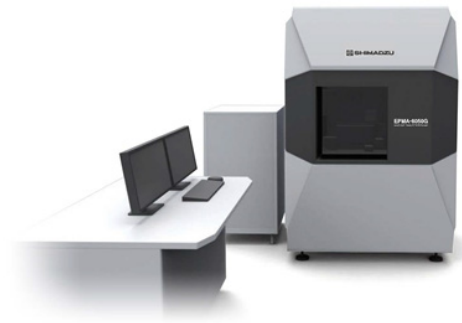
**Fig. 2 Appearance of EPMA (EPMA-8050G)**

The AG-Xplus autograph precision universal testing machine was used in static tensile tests, and the HITS-TX was used in high-speed tensile tests. Fig. 1 shows the condition of tests. Table 1 shows the test equipment used in this study. After the tests, the fracture surfaces were coated with gold and observed with an optical microscope and EPMA. Fig. 2 shows the appearance of the EPMA.

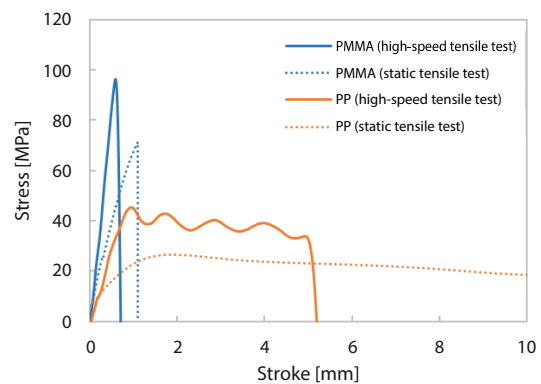
**Fig. 3 Stress-Stroke Curves**

The stress-stroke curves and test results are shown in Fig. 3 and Table 3, respectively. The tensile strengths of both PMMA and PP were higher in the high-speed tensile test than in the static tensile test, confirming the test speed dependency of the tensile strength of these two plastic materials.
