# Application News No. **P104** **i266**

## EPMA-8050G Electron Probe Microanalyzer High-Speed Impact Testing Machine

### Evaluation of Mechanical Characteristics and Fracture Surface Observation in Static and High-Speed Tensile Tests of Plastic Materials

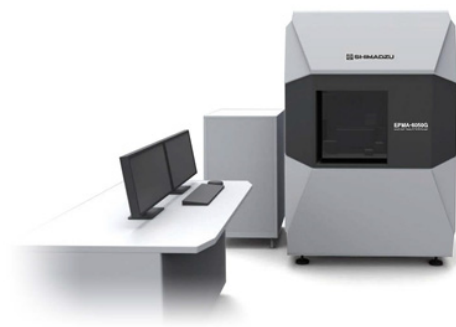
**Fig. 2 Appearance of EPMA (EPMA-8050G)**

The AG-Xplus autograph precision universal testing machine was used in static tensile tests, and the HITS-TX was used in high-speed tensile tests. Fig. 1 shows the condition of tests. Table 1 shows the test equipment used in this study. After the tests, the fracture surfaces were coated with gold and observed with an optical microscope and EPMA. Fig. 2 shows the appearance of the EPMA.

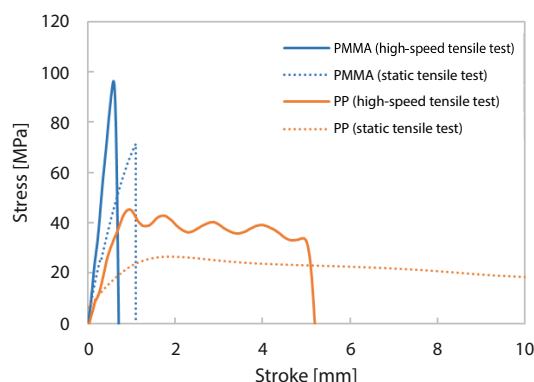
**Fig. 3 Stress-Stroke Curves**

The stress-stroke curves and test results are shown in Fig. 3 and Table 3, respectively. The tensile strengths of both PMMA and PP were higher in the high-speed tensile test than in the static tensile test, confirming the test speed dependency of the tensile strength of these two plastic materials.
