Application News

No. V29

High-Speed Video Camera

Fracture Observation and Observation of Strain Distribution of Plastic Material with Hole in Impact Compression Test

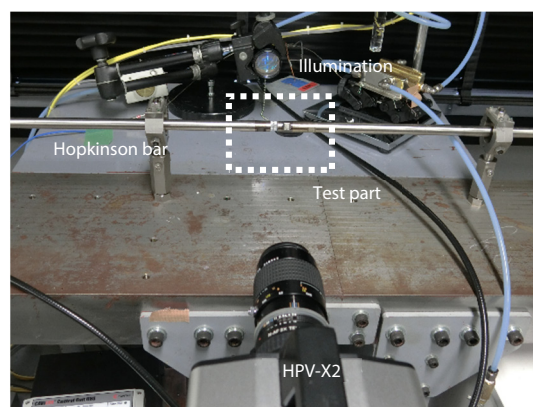
Fig. 1 Condition of Recording

The fracture behavior of an acrylic block was observed using an HPV-X2 high-speed video camera. Table 1 shows the recording equipment. Fig.1 and Fig.2 show the conditions of recording and the test part, respectively. Illumination was provided by a Cavilux® laser light source (manufactured by Cavitax Ltd.). Use of the Cavilux system with the HPV-X2 can be considered an appropriate combination for high-speed recording, as the Cavilux is capable of outputting pulses as short as 20 ns in response to the shutter signals of the HPV-X2. The test specimen was an acrylic plastic block having a round hole with a diameter of 2 mm in its center. Table 2 shows the recording conditions. In this study, observation from the front face of the hole, observation from the side of the hole, and observation for use in the DIC analysis were carried out.

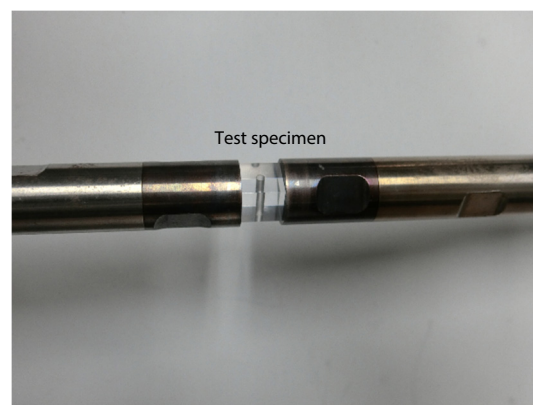
Fig. 2 Condition of Test Part

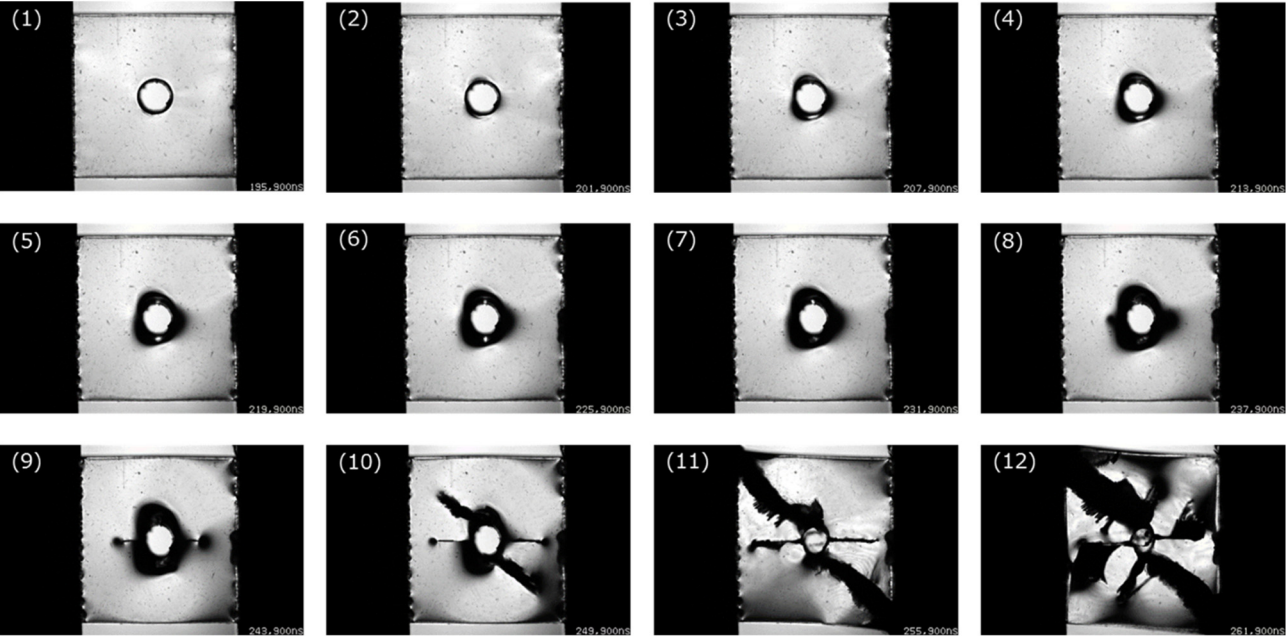
Fig. 3 shows the results of fracture observation from the front face of the hole. Deformation of the hole center can be observed from image (1) to image (6). In image (8), cracks initiate from both sides of the hole and grow in the horizontal direction. In image (10), cracks growing diagonally from the hole can also be seen, and in image (11), these cracks have reached final fracture before the horizontal cracks. As the diagonal cracks are considered to be caused by shearing, it is thought that the acrylic plastic specimen finally failed due to shear fracture, with the hole as the point of origin.

Fig. 3 Observation of Failure from Front of Hole (Time Interval Between Images: 6 μ s)

Fig. 4 shows the results of fracture observation from the side of the hole. In images (1) to (6), the specimen undergoes compressive deformation, and in image (7), cracks have occurred on the part of right and left sides of the hole. In image (8), these cracks have extended to the entire hole region, and they continue to grow in images (9) and (10). In image (11), cracks different from those in images (7) to (10) can also be observed, and final fracture occurs in image (12). The cracks in images (7) to (10) are thought to be the horizontal cracks in Fig. 3, and the cracks in images (11) and (12) are thought to be the diagonal cracks in Fig. 3.

The lengths of the horizontal and diagonal cracks were calculated based on the images in Fig. 3. Fig. 5 shows the relationship between the time from the start of the test and the crack length. Although the horizontal cracks grew at a constant speed until about 60 μs , crack growth slowed after that time. Subsequently, the cracks grew instantaneously at 64 μs , and final fracture occurred. On the other hand, the diagonal cracks initiated at around 50 μs , those cracks then grew at a substantially constant rate, and fracture occurred at 59 μs . When the respective crack growth rates were calculated from Fig. 5, it was found that the growth rate of the horizontal cracks was 130 m/s, while that of the diagonal cracks was 630 m/s, or approximately 5 times faster.

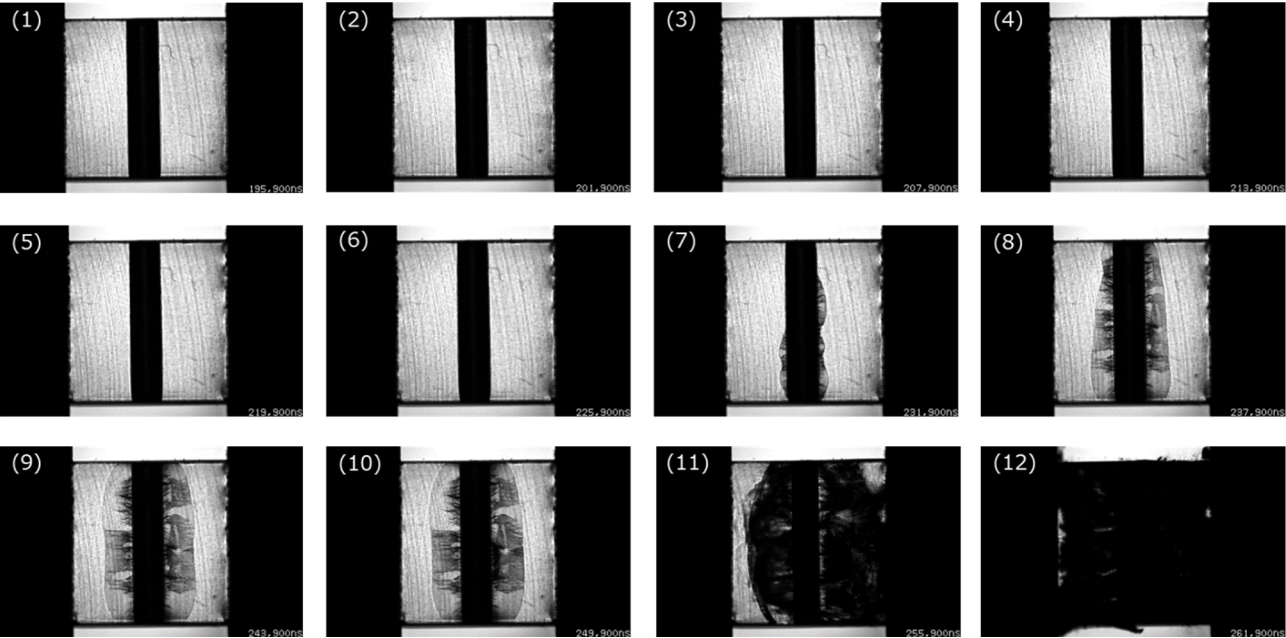
Fig. 4 Observation of Failure from Side of Hole (Time Interval Between Images: 6 μ s)

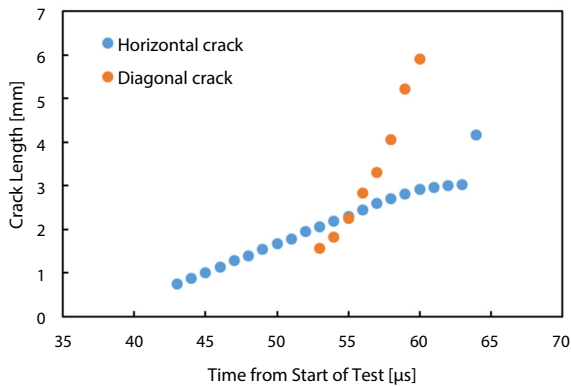
Fig. 5 Relationship of Time from Start of Test and Crack Length

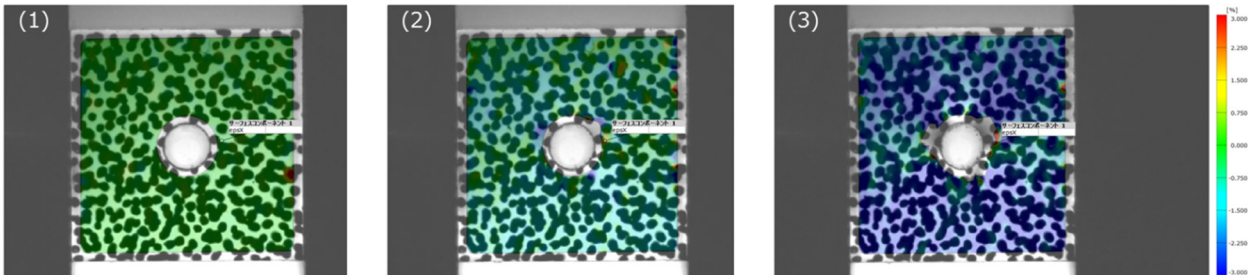
Fig. 6 shows the compressive strain distribution during the test obtained by the DIC analysis. The images from (1) to (3) show the strain distribution before crack initiation. In this figure, green and blue indicate small and large compressive strain, respectively. Thus, as the test progresses, an increase in strain in the compressive direction can be observed. On the other hand, Fig. 7 shows the compressive strain distribution after the specimen fractures. After fracture, the specimen separated largely into two pieces, one at the upper left and the other at the lower right, and a decrease in compressive strain from image (1) to image (3) could be confirmed.

Fig. 6 Strain Distribution in Compressive Direction During Test (Time Interval Between Images: 20 μs)

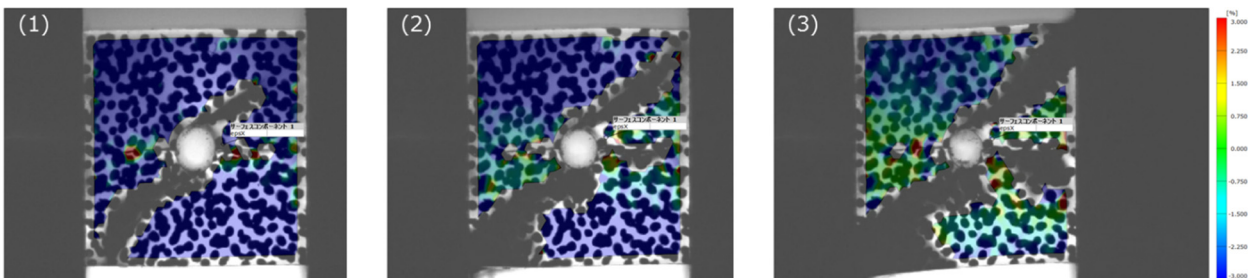
Fig. 7 Strain Distribution in Compressive Direction After Fracture (Time Interval Between Images: 3 μs)
