Application News

High-Speed Video Camera

Observing the Fracture of Unidirectional CFRP in Static Tensile Testing

No. V18

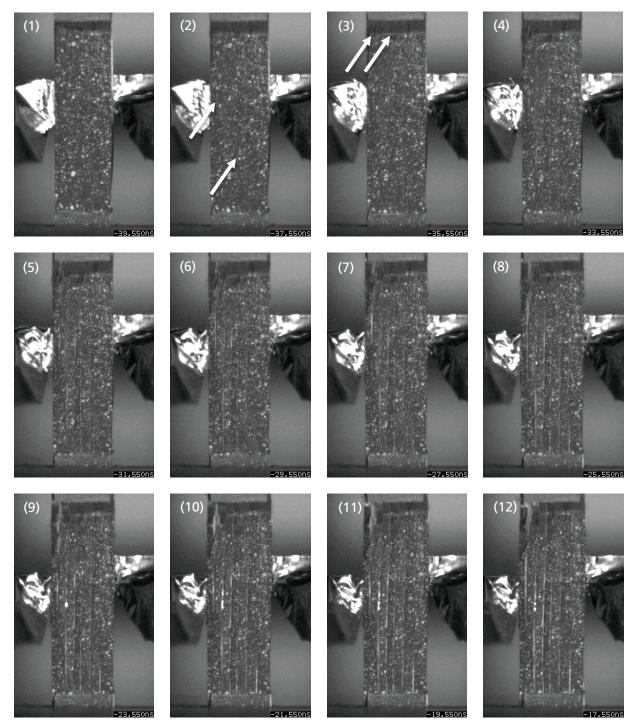
Fig. 4 Captured Images (Interval between captured images is 2 μs.)

The failure of unidirectional CFRP is shown in Fig. 4. Longitudinal cracks can be seen on the left side of the specimen in image (2) of Fig. 4. In image (3), these cracks have propagated as far as the upper tab. Longitudinal cracks can also be seen on the right side of the sample in image (3). Image (6) is a later view of the sample as it is breaking apart. Using the HPV-X2 allows for the observation of CFRP failure during static tensile tests, which is useful for future CFRP development.
