Electron Probe Microanalyzer

No. **P107**

Analysis of Lead-Free Solder Joint Interface

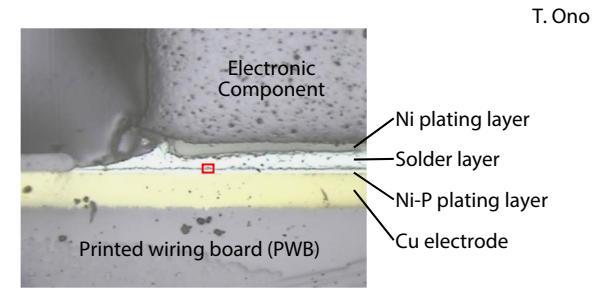
Fig. 1 Optical Micrograph of Solder/Electroless Ni-P Plating Joint Interface

In solder joints on printed wiring boards (PWB), an electroless Ni-P plating is applied on Cu electrodes. Fig. 1 shows the composition of each layer between the PWB and the electronic components mounted on the board. Fig. 2 shows the enlarged mapping results of the region in the red box in Fig. 1. This figure shows the joint interface between the solder and the electroless Ni-P plating. It can be understood that heterogenous dendritic intermetallic compounds of Ni, Cu, and Sn and a P-rich layer have formed in this region. Fig. 3 shows the enlarged mapping results for the areas in the red boxes in Fig. 2. The condition of P concentration with a thickness of several 100 nm and the distribution of fine Aq particles with size of approximately 100 nm can be captured clearly by measurement under a low accelerating voltage condition (7 kV) to reduce the spread of X-ray spatial resolution.

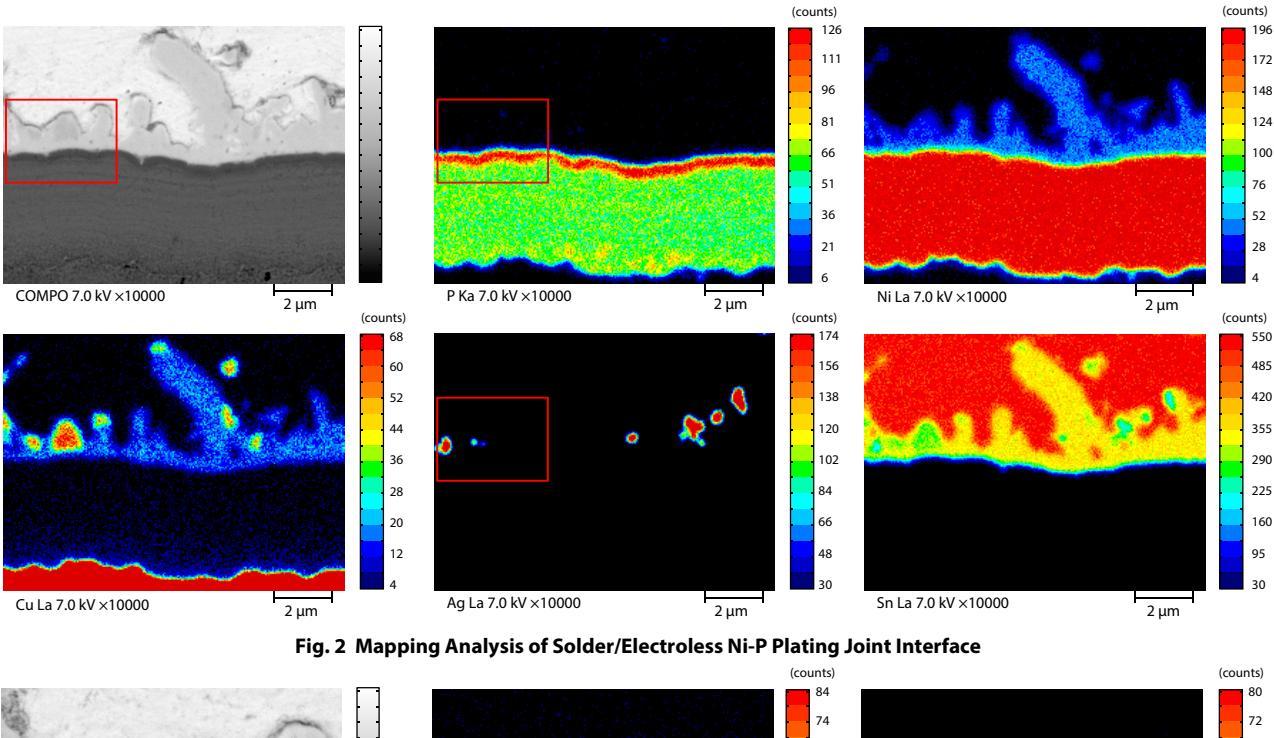
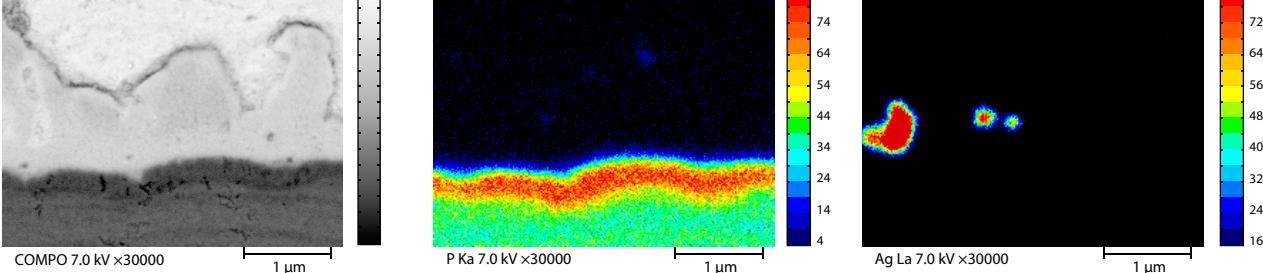
Fig. 3 Enlarged Images of Mapping Analysis of Solder/Electroless Ni-P Plating Joint Interface

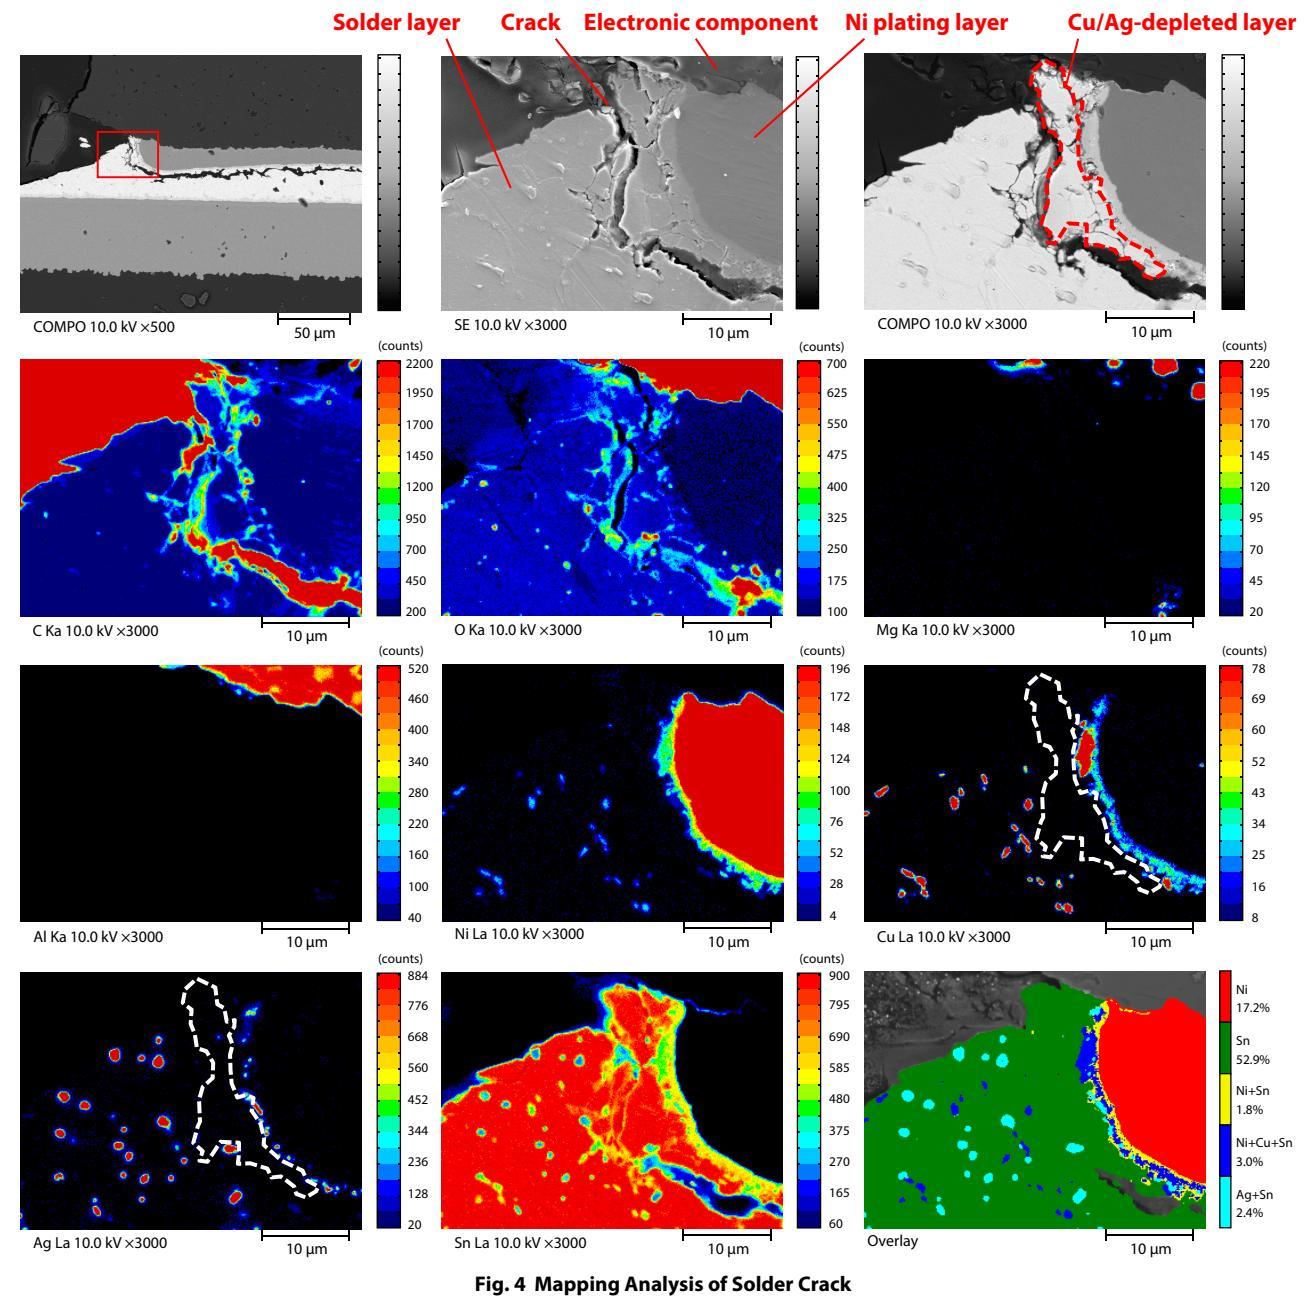
Next, a mapping analysis of an area where a crack occurred in a PWB solder joint was conducted. Fig. 4 shows the mapping analysis results. The overlay image (lower right) shows the distribution when 4 elements (Ni, Cu, Ag, Sn) were overlaid, and indicates that an intermetallic compound layer consisting of mainly Ni, Cu, and Sn has formed at the interface between the solder and the Ni plating.

Focusing on the region between the intermetallic compound layer and the crack (region outlined by the red dotted line in the COMPO image at upper right in Fig. 4), it can be understood that depletion of Cu and Ag has occurred (as shown by the white dotted lines in the element distribution images for Cu and Ag in Fig. 4).

Based on these results, it can be inferred that Cu and Ag, which are originally components of the solder, dispersed and concentrated at the interface with the Ni plating layer, and the crack occurred due to the deterioration of solder strength accompanying the formation of this Cu- and Ag-depleted layer. This experiment shows that valuable information for analysis of the cause of cracks in solder joints can also be obtained by EPMA.
