# Application News

HPV™-X2 High-Speed Video Camera/HITS™-PX High-Speed Impact Testing Machine

## Fracture Observation in Puncture Impact Testing on Glass

T. Yano\*1, F. Yano  
\*1 Tokyo Institute of Technology

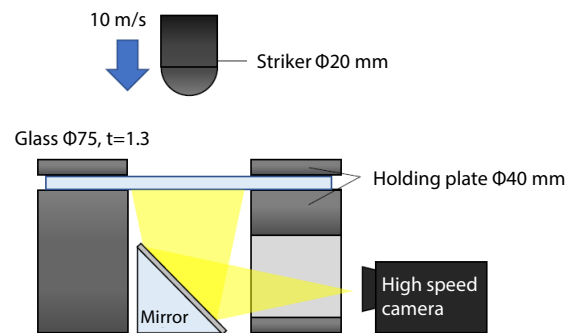
Fig. 2 Schematic Diagram of Test Unit

Using the HPV-X2 high-speed video camera and HITS-PX high-speed impact testing machine, we observed the fracture behavior of two types of tempered glass and untempered glass in puncture impact testing. Table 1 shows the test instruments. Figs. 1 and 2 show the photos and schematic diagram of the instruments, respectively. By setting up a mirror as shown in Fig. 2, we could observe the glass being punctured by the striker directly from below.

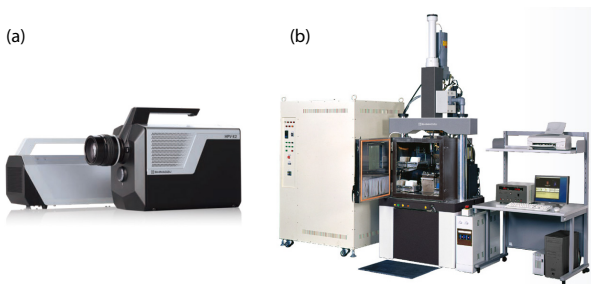
Fig. 1 Photos of Test Instruments  
(a) HPV™-X2 high-speed video camera  
(b) HITS™-PX high-speed impact testing machine

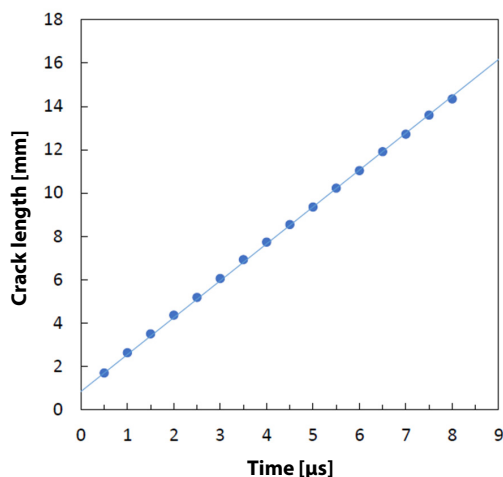
Fig. 5 Crack Length and Time in Field-Assisted Tempered Glass

Fig. 5 shows, as an example, the relationship between crack length and time for the field-assisted tempered glass. Table 4 summarizes the crack growth rates calculated from the relationship between the crack length and time for each specimen. Although the obtained crack growth rates were almost similar, the tempered glass was found to exhibit a slightly higher value.

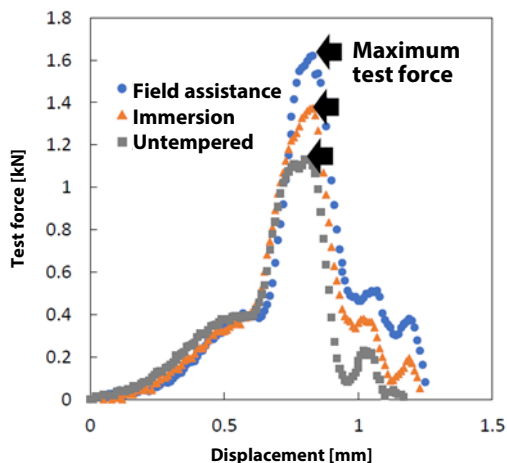
Fig. 3 Test Force-Displacement Diagram

Table 3 shows the maximum test force and failure stress<sup>\*2</sup> of each specimen in the puncture impact test. Fig. 3 shows the test force-displacement diagram. From these results, it was found that the maximum test force of the field-assisted tempered glass was the highest.

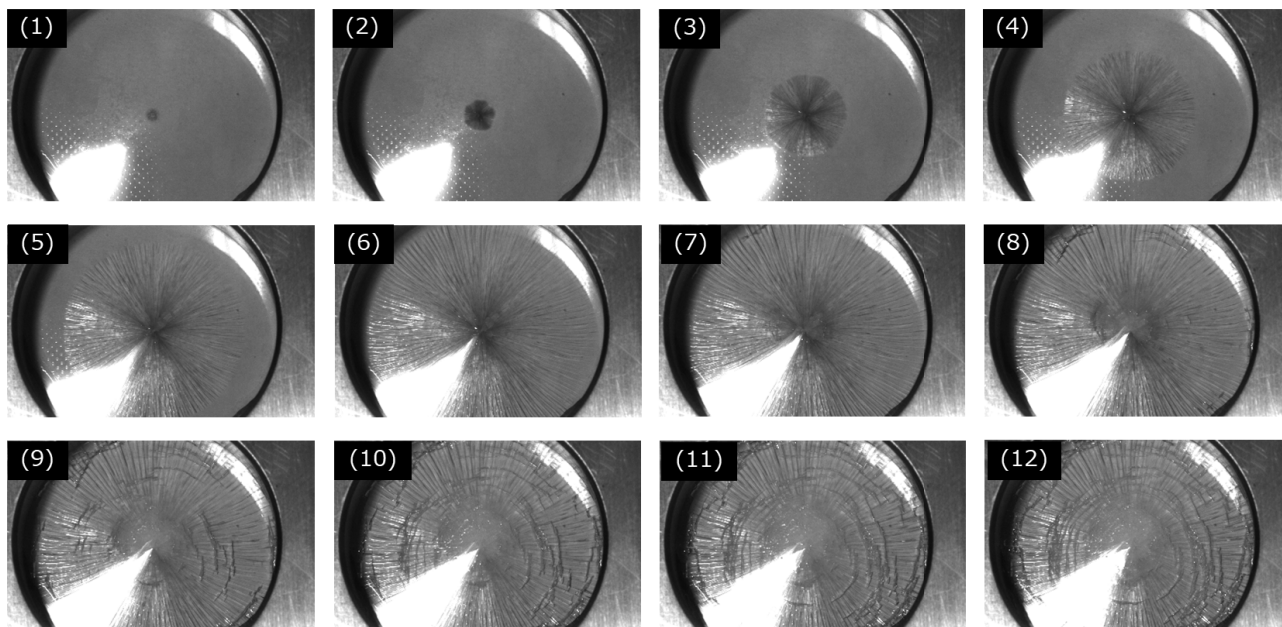
Fig. 4 Fracture of Field-Assisted Tempered Glass (time interval between images: 500 ns)

As an example of fracture observation in puncture impact testing, Fig. 4 shows how the fracture propagated on the field-assisted tempered glass. Image (1) in Fig. 4 shows the moment when the striker made contact with the glass. Then, from images (2) to (6), the cracks were observed to grow radially. The upper left corner of image (7) then shows that a crack propagated in a different direction from that of the cracks in images (2) to (6), and in images (8) to (12), multiple cracks propagated in concentric circles, showing that the field-assisted tempered glass was more finely fractured.

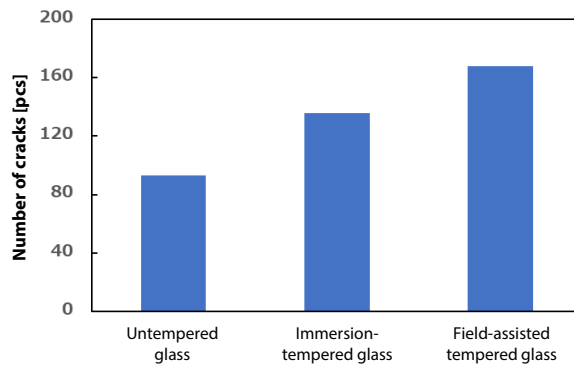
Fig. 7 Number of Cracks in Each Glass

Fig. 6 shows the fracture of each type of glass. Fig. 7 shows the results of counting the number of cracks propagating radially from these images. From Fig. 7, it became clear that the higher the failure stress, the higher the number of cracks in the glass.
