Application News

No. N130

Microfocus X-Ray Inspection System

An Example Observation of a Smartphone Using Xslicer SMX-6000

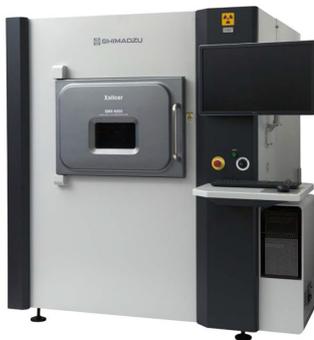
Fig. 1 Xslicer SMX-6000 Microfocus X-Ray Inspection System

This article introduces an example observation of a smartphone using the Xslicer SMX-6000 microfocus X-ray inspection system (Fig. 1).

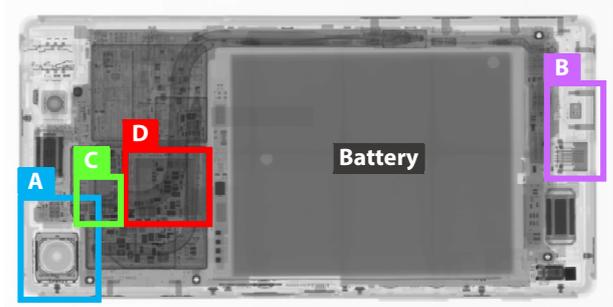
Fig. 2 is a fluoroscopic image taken using Xslicer SMX-6000 (using the panorama function). A lithium-ion battery is in the central area and a u-shaped electronic circuit board surrounds the battery. In addition, a camera (A), a USB port (B), and other electronic components are mounted around them. Through fluoroscopic observation of the entire product, the general internal conditions and placements of components can be viewed at a glance.

Fig. 2 Fluoroscopic Image of a Smartphone (Taken using the panorama function)

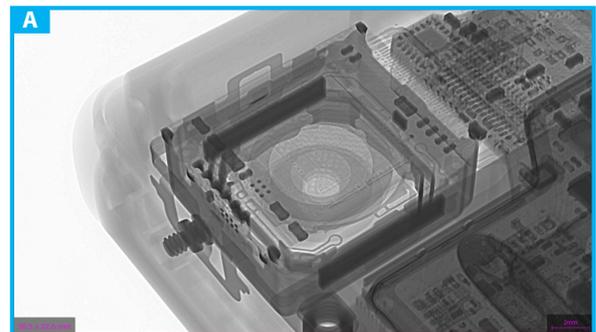
Fig. 3 Fluoroscopic Image of the Camera (A)

Figs. 3 to 5 are high magnification images of the components A to C in Fig. 2. Each image was taken by changing the observation magnification and angle. Defects can be detected effectively and conveniently since images optimal for inspection items can be obtained easily and quickly. Fig. 5 shows that there are multiple voids in the ball grid array (BGA). However, defects may be difficult to identify when the structure is complex with many layers; for example, components may appear as overlapped in the fluoroscopic images. X-ray computed tomography (CT) imaging is useful in such cases.

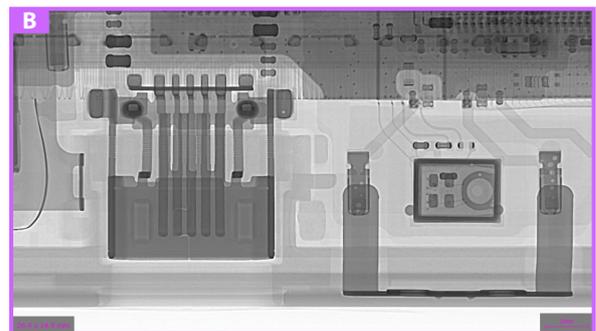
Fig. 4 Fluoroscopic Image of the USB Port (B)

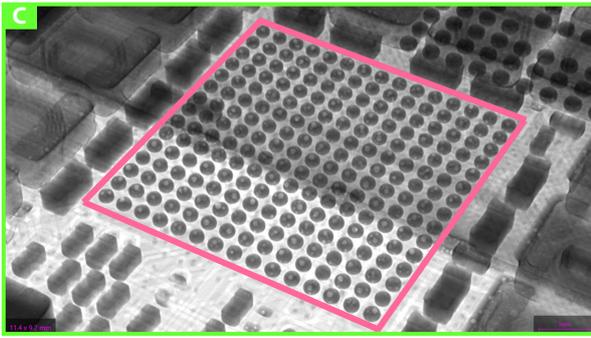
Fig. 5 Fluoroscopic Image of a BGA (C)

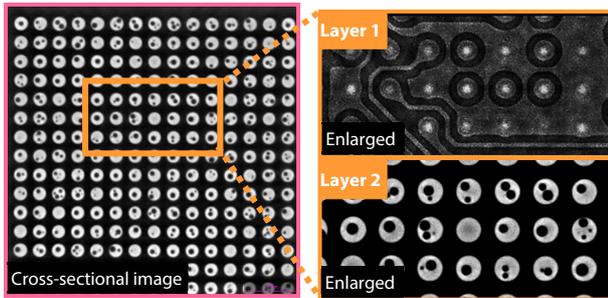
Fig. 6 Cross-Sectional Images of a BGA (C)

Fig. 6 shows images of the same section as Fig. 5 acquired by CT imaging at low and high magnifications. Layer 1 and Layer 2 are images of the data of two different layers obtained from the same imaging data. Layer 1 can be used to ensure that there is no disconnection in the electronic circuit pattern and that the solder bumps are properly bonded. Layer 2 can be used to check the void distribution at an arbitrary height. Various data can be obtained from a single observation point by changing the size of the field of view for image acquisition or by extracting the data of different layers.

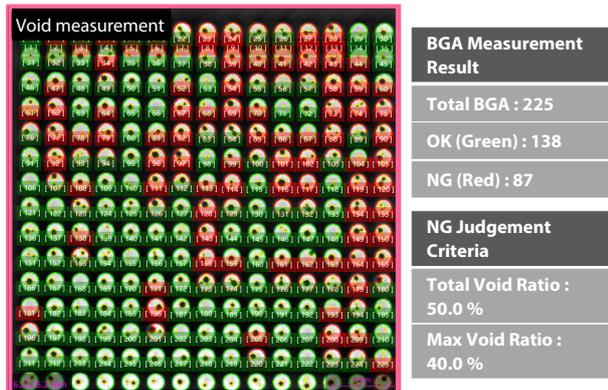
Fig. 7 Measurement of BGA (C) Voids

Fig. 7 presents the results of the void ratio calculation obtained from the cross-sectional images in Fig. 6 using the BGA measurement function. With this inspection system, measurements can be performed easily without the need for complex parameter settings. Furthermore, defective sections can be identified at a glance by setting arbitrary pass/fail criteria. (Sections that pass (OK) are shown in green and sections that fail (NG) are shown in red.) In addition to pass/fail evaluations based on void ratios as presented in Fig. 7, evaluations can also be based on bump diameters or bump roundness.

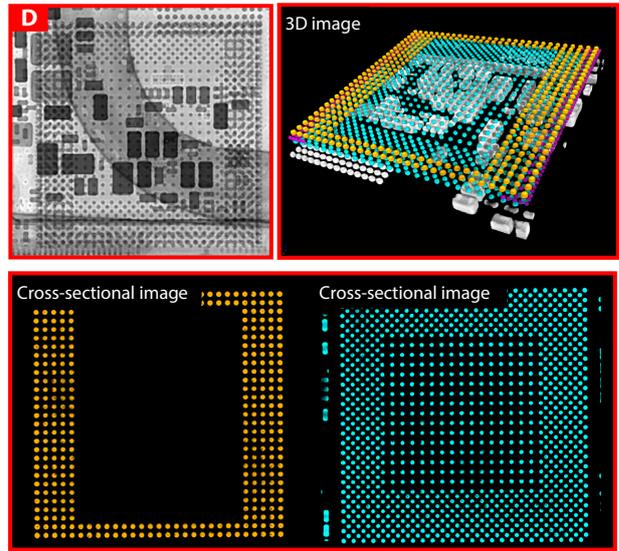
Fig. 8 Fluoroscopic Image, Cross-Sectional Images, and 3D Image of a BGA (D)

Fig. 8 shows a fluoroscopic image and cross-sectional images of a BGA (D in Fig. 2) and a three-dimensional (3D) image of the same BGA generated from the CT imaging data. It is extremely difficult to grasp the structure of this BGA by fluoroscopic observation because it consists of multiple layers and resistors are arranged above and below the layers. In such cases, cross-sectional images and 3D images generated from the CT imaging data are useful.

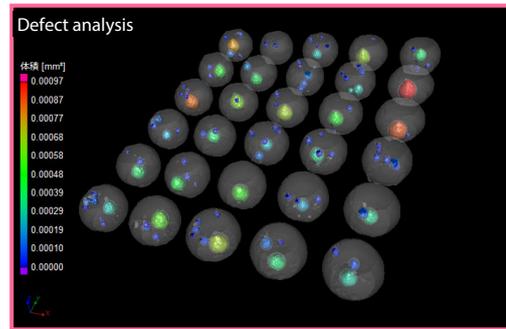
Fig. 9 Defect Analysis of a BGA (C)

Fig. 9 is an image of a defect analysis obtained using a 3D image processing software based on the CT imaging data of a BGA (C). The results are visualized by displaying only the voids in color and making the solder bumps semi-transparent.

The analysis result data such as the volume, diameter, and position of the voids can be converted into graphs or tables as a CSV file.
