Application News

HPV™-X2 High-Speed Video Camera/HITS™-PX High-Speed Impact Testing Machine

Fracture Observation in Puncture Impact Testing on Glass

01-00119-EN

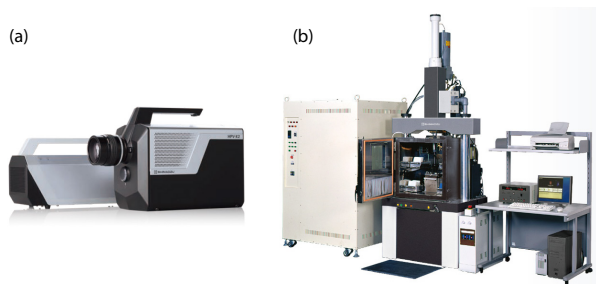
Fig. 1 Photos of Test Instruments
(a) HPV™-X2 high-speed video camera
(b) HITS™-PX high-speed impact testing machine

Using the HPV-X2 high-speed video camera and HITS-PX high-speed impact testing machine, we observed the fracture behavior of two types of tempered glass and untempered glass in puncture impact testing. Table 1 shows the test instruments. Figs. 1 and 2 show the photos and schematic diagram of the instruments, respectively. By setting up a mirror as shown in Fig. 2, we could observe the glass being punctured by the striker directly from below.

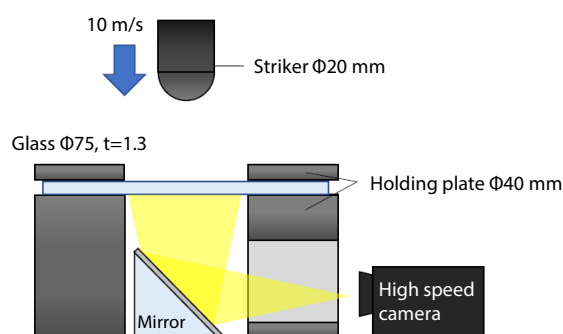
Fig. 2 Schematic Diagram of Test Unit

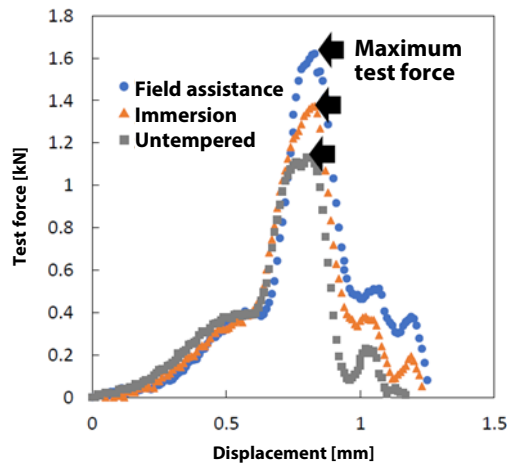
Fig. 3 Test Force-Displacement Diagram

Table 3 shows the maximum test force and failure stress^{*2} of each specimen in the puncture impact test. Fig. 3 shows the test force-displacement diagram. From these results, it was found that the maximum test force of the field-assisted tempered glass was the highest.

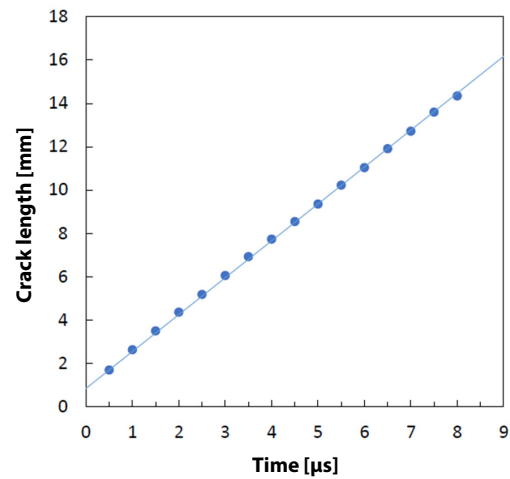
Fig. 5 Crack Length and Time in Field-Assisted Tempered Glass

Fig. 5 shows, as an example, the relationship between crack length and time for the field-assisted tempered glass. Table 4 summarizes the crack growth rates calculated from the relationship between the crack length and time for each specimen. Although the obtained crack growth rates were almost similar, the tempered glass was found to exhibit a slightly higher value.

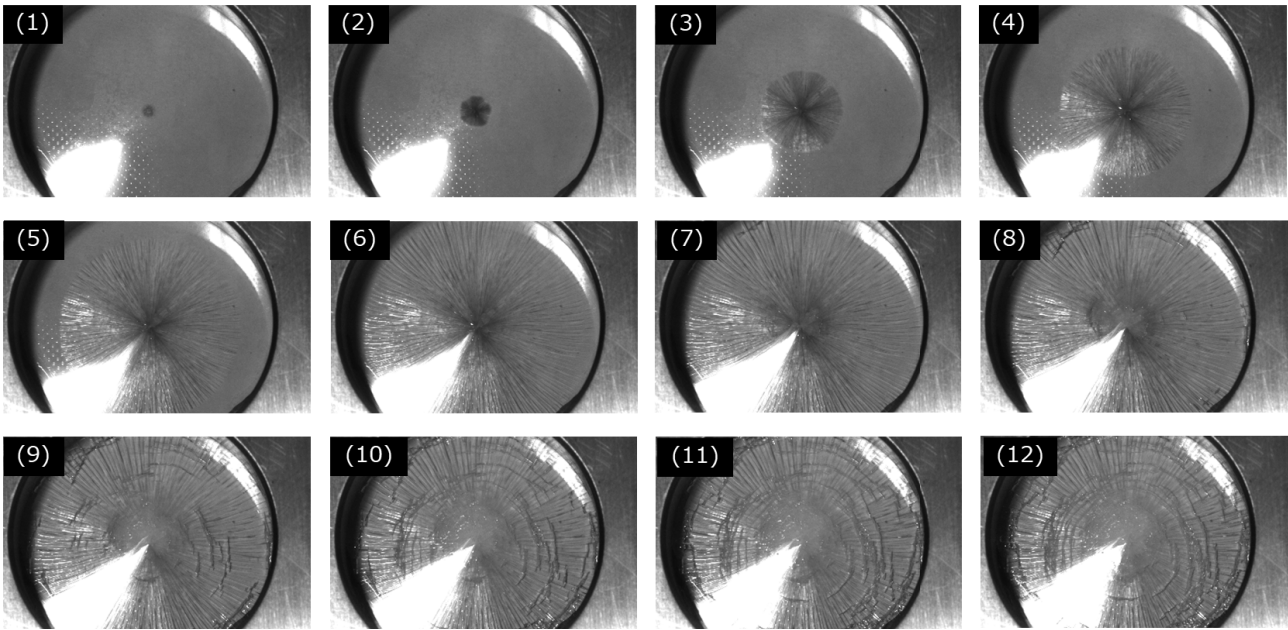
Fig. 4 Fracture of Field-Assisted Tempered Glass (time interval between images: 500 ns)

As an example of fracture observation in puncture impact testing, Fig. 4 shows how the fracture propagated on the field-assisted tempered glass. Image (1) in Fig. 4 shows the moment when the striker made contact with the glass. Then, from images (2) to (6), the cracks were observed to grow radially. The upper left corner of image (7) then shows that a crack propagated in a different direction from that of the cracks in images (2) to (6), and in images (8) to (12), multiple cracks propagated in concentric circles, showing that the field-assisted tempered glass was more finely fractured.
