## Application News

### Three-Point Bending Fatigue Tests of Welded Material Using the SEM Servopulser

01-00792-EN

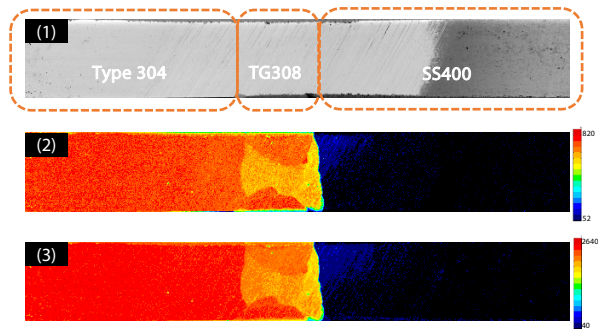
Fig. 5 Observation Images Using EPMA  
(1) Backscattered electron image (2) Ni (3) Cr

First, element mapping of the test samples was performed before the fatigue test. The test specimens consisted of Type 304 and SS400 with a TG308 weld in the center, so differences in Ni, Cr, etc. were found. Fig. 5 shows a backscattered electron image and an element mapping analysis image for Ni and Cr. The boundaries between Type 304, TG308, and SS400 could be clearly determined, as shown in Fig. 5 (2) and (3).

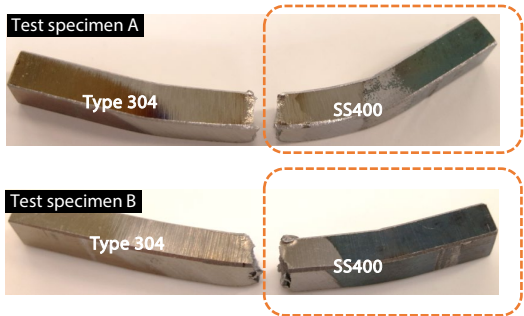
Fig. 6 Test Specimens A and B after the Fatigue Tests

Next, element mapping analysis was performed by the EPMA on the SS400 side of the test specimens A and B. Fig. 6 shows a photograph of the test specimens after the tests. The failure of specimen A occurred virtually in the center, while test specimen B failed on the SS400 side. Fig. 7 shows images observed using the EPMA of the fracture surface of test specimen A on the SS400 side. Fig. 7 (3) and (4) show that in the center of the test specimen, the Ni and Cr content was low, but around it, the Ni and Cr components were high. This was probably because the SS400 welding surface and the welding rod TG308 components were detected.

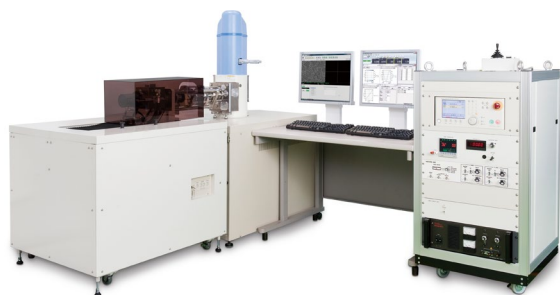
Fig. 9 SEM Servopulser™

The SEM Servopulser combines a scanning electron microscope (SEM) with a fatigue testing machine (Servopulser). This enables the extension of cracks to be observed in detail during tests. In this case, observations using the SEM Servopulser were performed up to a maximum loading stress of 700 MPa. Fig. 9 shows a photo of the SEM Servopulser.
