# Application News

## No. V26

### High-Speed Video Camera

## Observation of Fracture Behavior of Resin Material from an Impact Compression Test by the Hopkinson Bar Method

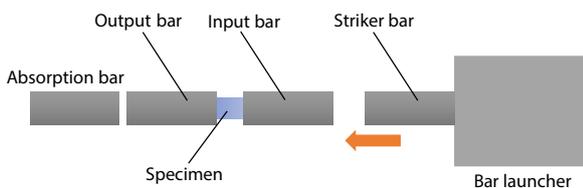
**Fig. 1 Schematic Diagram of the Hopkinson Bar Method**

Understanding the properties of materials is important in designing products. For this reason, there are various testing standards such as tensile testing, compression testing, and bend testing. Regarding transport aircraft, the possibility of sustaining impact loads must be taken into account, meaning that in order to accurately understand the properties of a material, impact properties must be grasped in addition to static properties. In particular, impact testing is necessary since the stress-strain characteristics of a material may differ between when it is subjected to a static load and when it is subjected to an impact load. The Hopkinson bar method is one method for impact testing. Proposed by Bertram Hopkinson, this method deforms a specimen by impact. A striker bar is fired against an input bar by a bar launcher, transmitting a compressive elastic wave through the input bar to apply a sudden force to the specimen which is contacting the input bar.<sup>1)</sup> A schematic of the Hopkinson bar method is illustrated in Fig. 1.

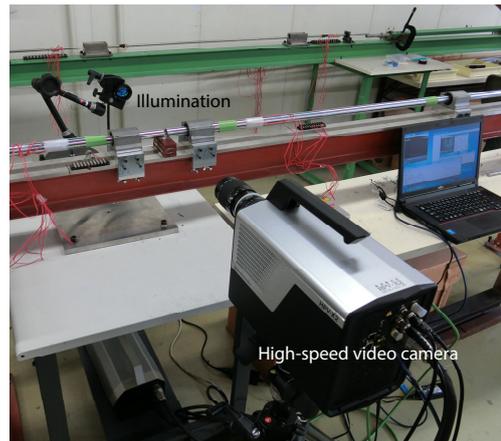
**Fig. 2 Setup of Recording Equipment**

Fracture behavior was observed using the HPV™-X2 high-speed video camera (hereinafter referred to as HPV-X2). The equipment used for recording in this study is shown in Table 1. Figs. 2 and 3 show the observation and test setup. Cavilux was employed for illumination. Cavilux is a laser light which can emit short pulses down to 20 ns in accordance with the shutter signals of the HPV-X2, making it optimal for high-speed recording.

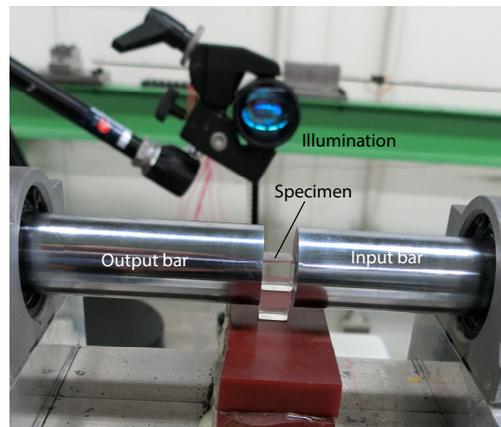
**Fig. 3 Test Setup with Specimen Inserted**

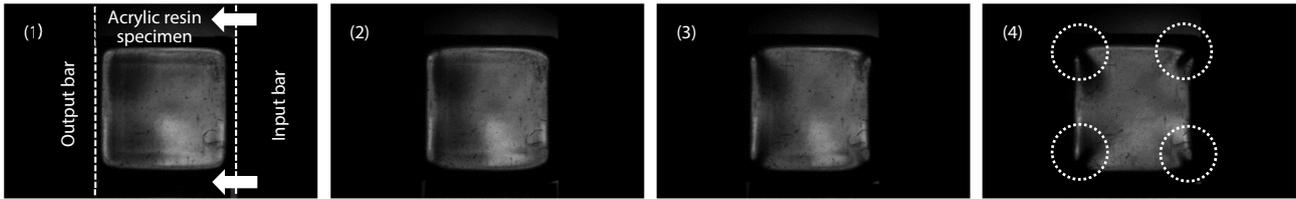
Fig. 4 Captured Images (Time interval between images: 140  $\mu$ s)

The test was recorded at 500,000 frames per second. Examples of the captured images (frames) are shown in Fig. 4. The time interval between the images in Fig. 4 is 140  $\mu$ s. These images show that deformation was concentrated at the four corners of the acrylic resin specimen. Fig. 5 shows the crack propagation during the breakage of the specimen. Fig. 4-(4) and Fig. 5-(1) are the same image. The images show that a crack first occurred in Fig. 5-(2) at the surface of the specimen contacting the output bar, and the crack reached the surface contacting the input bar in Fig. 5-(7). The white arrows in Fig. 5 indicate the length of the crack inside the acrylic resin specimen.

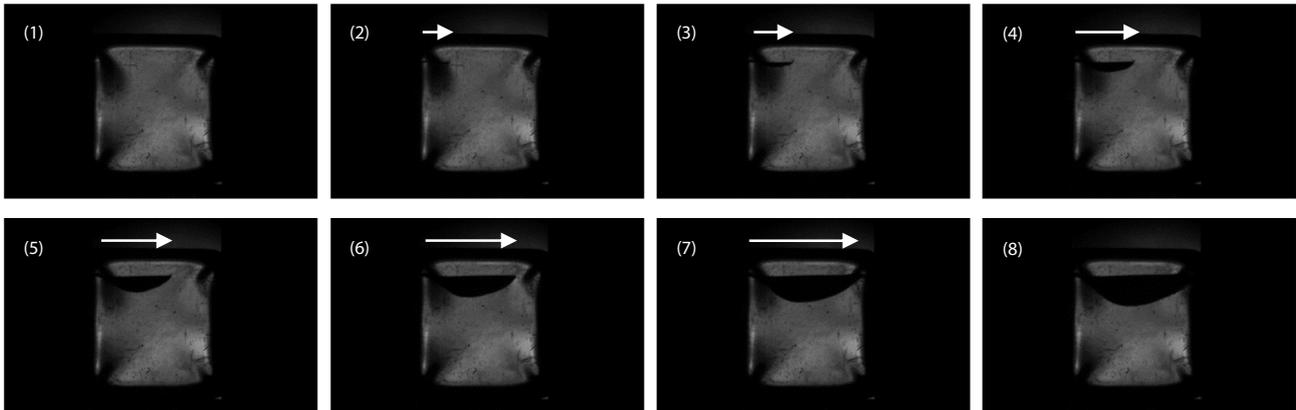
Fig. 5 Crack Propagation (Time interval between images: 2  $\mu$ s; Fig. 5-(1) is same image as Fig. 4-(4))
