Application News

High-Speed Video Camera

Observation of Fracture Behavior of Resin Material from an Impact Compression Test by the Hopkinson Bar Method

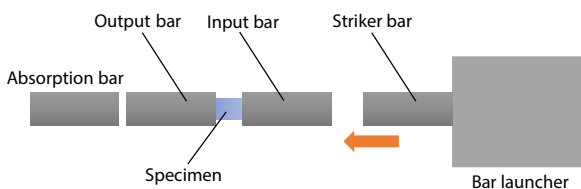
Fig. 1 Schematic Diagram of the Hopkinson Bar Method

Understanding the properties of materials is important in designing products. For this reason, there are various testing standards such as tensile testing, compression testing, and bend testing. Regarding transport aircraft, the possibility of sustaining impact loads must be taken into account, meaning that in order to accurately understand the properties of a material, impact properties must be grasped in addition to static properties. In particular, impact testing is necessary since the stress-strain characteristics of a material may differ between when it is subjected to a static load and when it is subjected to an impact load. The Hopkinson bar method is one method for impact testing. Proposed by Bertram Hopkinson, this method deforms a specimen by impact. A striker bar is fired against an input bar by a bar launcher, transmitting a compressive elastic wave through the input bar to apply a sudden force to the specimen which is contacting the input bar.¹⁾ A schematic of the Hopkinson bar method is illustrated in Fig. 1.

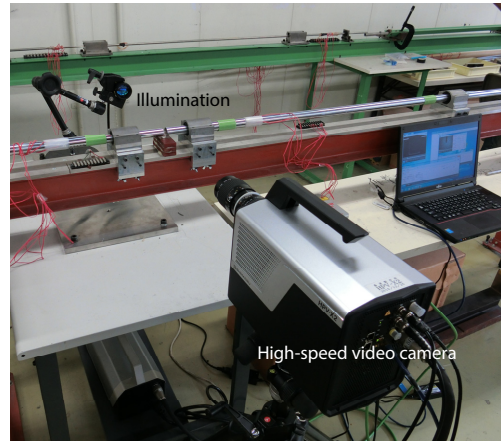
Fig. 2 Setup of Recording Equipment

Fracture behavior was observed using the HPV™-X2 high-speed video camera (hereinafter referred to as HPV-X2). The equipment used for recording in this study is shown in Table 1. Figs. 2 and 3 show the observation and test setup. Cavilux was employed for illumination. Cavilux is a laser light which can emit short pulses down to 20 ns in accordance with the shutter signals of the HPV-X2, making it optimal for high-speed recording.

High-Speed Video Camera	: HPV-X2
Lens	: One 105 mm macro lens, two teleconverters
Illumination	: Cavilux

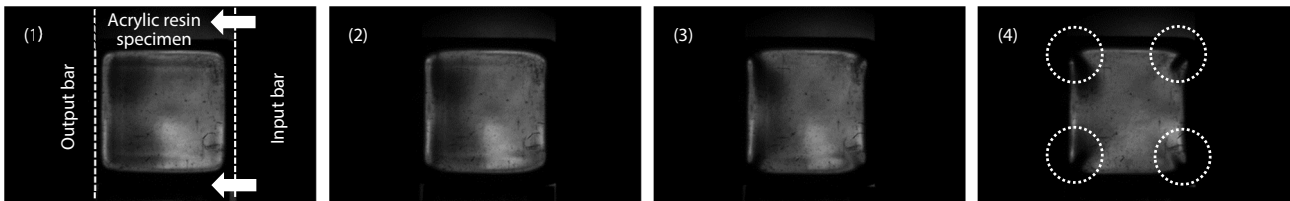
Fig. 4 Captured Images (Time interval between images: 140 μ s)

The test was recorded at 500,000 frames per second. Examples of the captured images (frames) are shown in Fig. 4. The time interval between the images in Fig. 4 is 140 μ s. These images show that deformation was concentrated at the four corners of the acrylic resin specimen. Fig. 5 shows the crack propagation during the breakage of the specimen. Fig. 4-(4) and Fig. 5-(1) are the same image. The images show that a crack first occurred in Fig. 5-(2) at the surface of the specimen contacting the output bar, and the crack reached the surface contacting the input bar in Fig. 5-(7). The white arrows in Fig. 5 indicate the length of the crack inside the acrylic resin specimen.
