Application News

Industrial X-Ray Inspection System

No.N112

Inner Observation of Aluminum Die Casting Parts

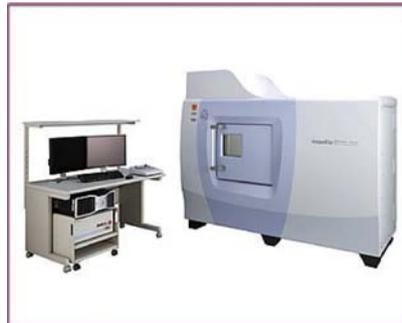
The inspeXio SMX-225CT microfocus X-ray CT system (shown in Fig. 1) was used to obtain the images.

Fig.1 External Appearance of the inspeXio SMX-225CT X-Ray CT System

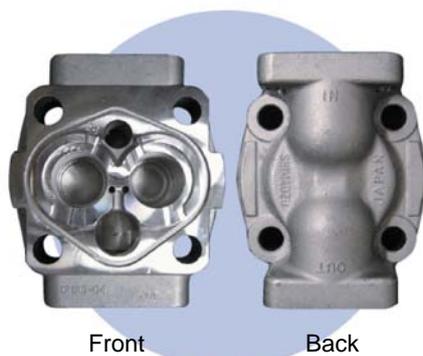
The sample utilized for observation in this case was the aluminum die cast part shown in Fig. 2.

Fig.2 External Appearance of the Sample (Aluminium Die Cast Part)

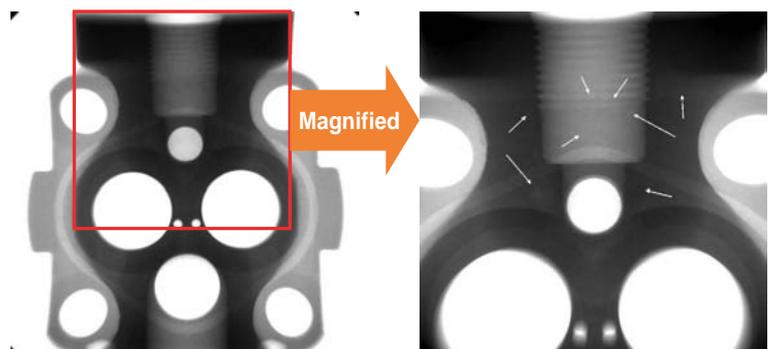
Images of this sample taken using conventional X-ray fluoroscopy are shown in Fig. 3. The right-hand image is a

magnified view. Multiple blowholes and porosities, marked with arrows, are evident at the center of the image. It is difficult however to discern their depth, directional positioning, or shape in any detail.

Fig.3 Example of Fluoroscopic Image for an Aluminium Die Cast Part

Accordingly, to perform a more detailed analysis, focused observations of the blowholes and porosities were made using MPR (Multi Planner Reconstruction). In this approach, cone beam CT imaging was performed under the conditions in which the fluoroscopic images in Fig. 3 were obtained. Any cross-sectional image was then reconstructed from the CT images obtained in this way. (Fig. 4)
Fig.4, (1) shows a cross-sectional image corresponding to the red frame in the fluoroscopic image to the left (identical to Fig. 3.), (2) shows a vertical section reconstructed from the \bullet line in (1),

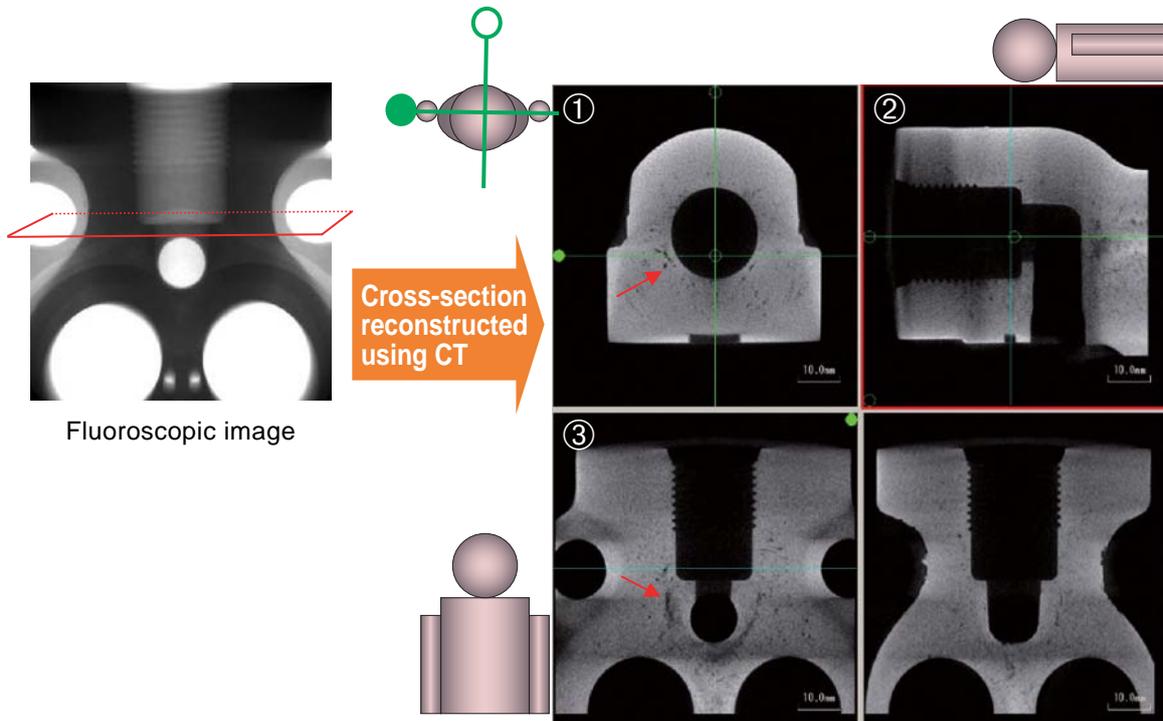
while (3) shows a vertical section reconstructed from the \circ line in (1).
In examining these images, the positioning and arrangement of the blowholes and porosities, which were difficult to ascertain from the fluoroscopic image, are now clearly evident. (For example, a large pore cavity is evident at the position indicated by the red arrow in Fig. 4.)
It is also possible to create 3-dimensional images based on this CT imaging data. (Fig. 5)

Fig.4 Example of CT Image for an Aluminum Die Cast Part

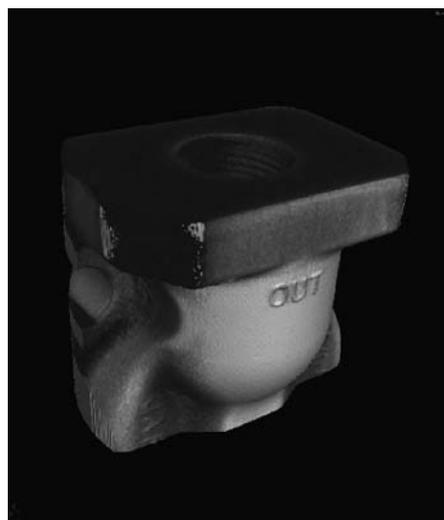
Fig.5 Example of 3-Dimensional Image for an Aluminum Die Cast Part

As an example of statistical analysis, the defect detection software provided with the system is capable of automatically detecting the blowholes and porosities in Fig. 5, color coding the defects by

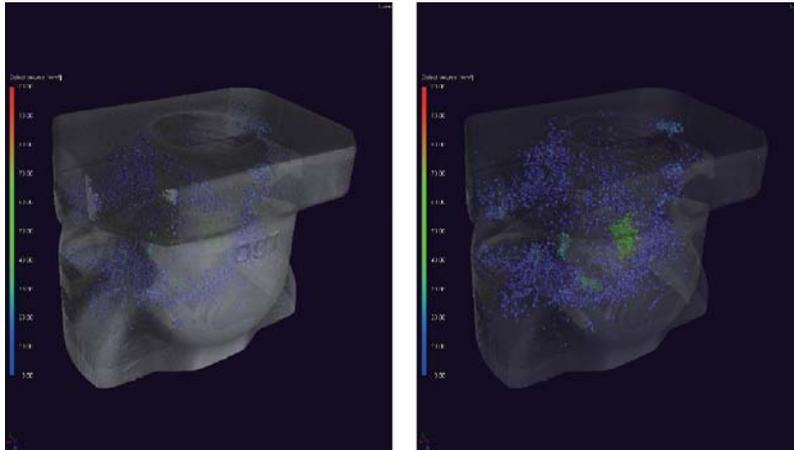
size, and then displaying a 3-dimensional image of the results. Fig. 6 illustrates this process. Here, the size (small: blue → large: green) and distribution of the blowholes and porosities are easily determined.

Fig.6 Example of 3-Dimensional Image for an Aluminum Die Cast Part

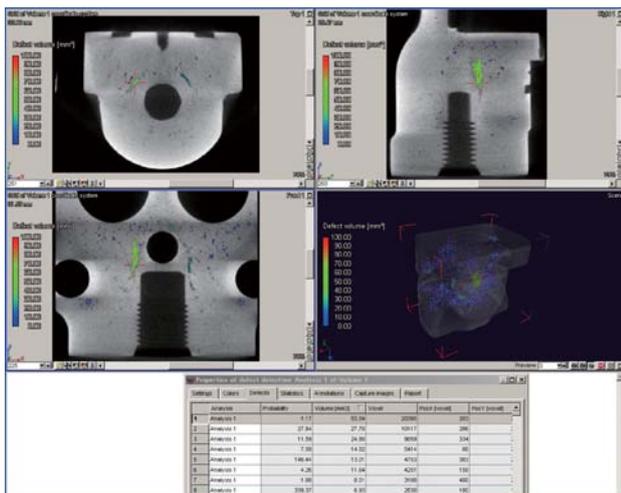
Fig. 7 shows the process of marking the largest blowholes and porosities identified from the image,

and then digitizing their position data for display. Since the blowholes and porosities detected are digitally classified on an individual basis, it is simple to display charts of the relationship between pore cavity size and frequency, as shown in Fig. 8.

Fig.7 Example of Defect Analysis for an Aluminum Die Cast Part

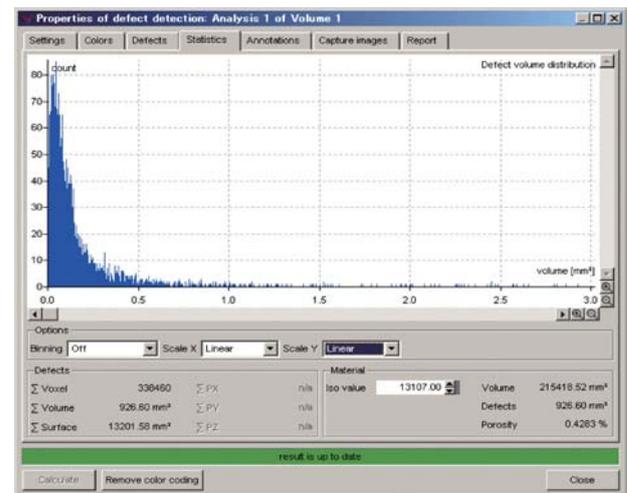
Fig.8 Example of Defect Analysis for an Aluminum Die Cast Part
