# Current Medical Care and Approaches to COVID-19, and the Benefits of a Shimadzu Mobile X-Ray System

— Osaka Prefectural Nakakawachi Emergency and Critical Care Center —

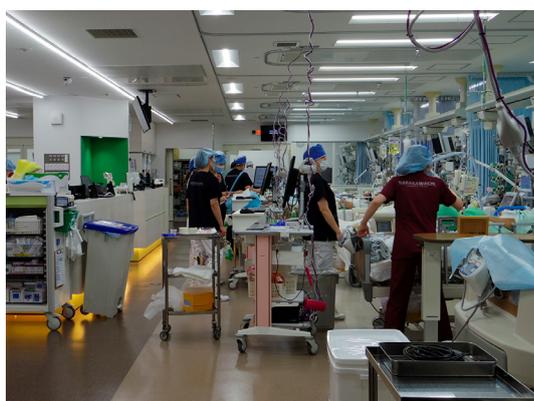
All 8 ICU beds converted for negative pressure operation due to the pandemic

During the first wave, the center treated 13 severe cases and 2 of our 8 ICU beds were operated as negative pressure rooms. As the number of cases increased, we switched to operating all 8 beds under negative pressure.

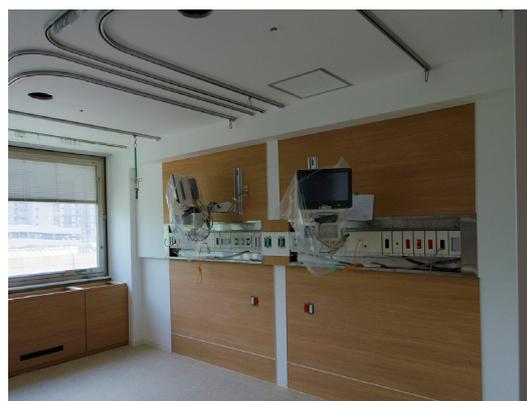
Nine of 22 general ward beds converted to negative pressure rooms

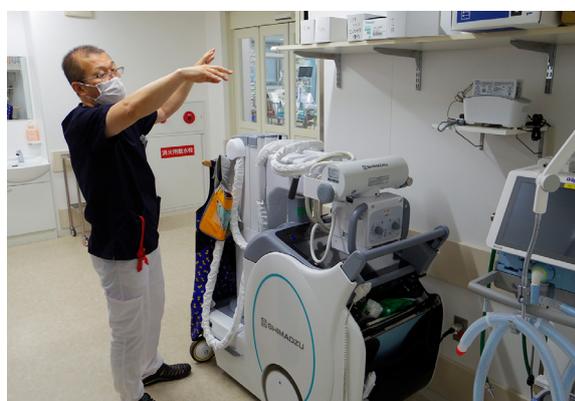
Thanks to the collapsible column, the system can even be stored under shelving.

**Mikami** Looking at the changes to MobileDaRt, they seem to have made it more practical. With the collapsible column and pockets on the main unit to

store equipment, it looks like some thought has been put into how the system will be used in a medical setting.

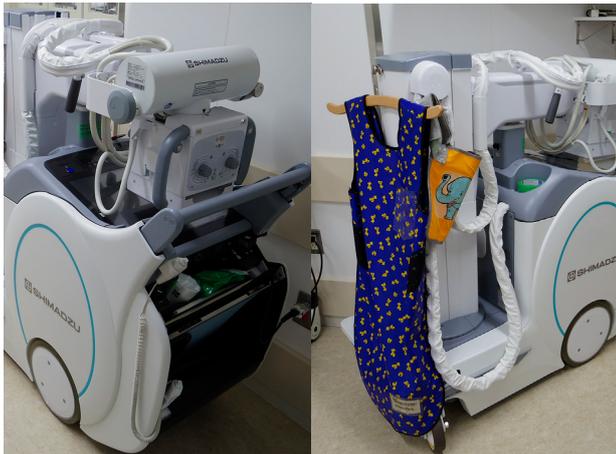
During hospital rounds, plastic bags and cleaning wipes for infection control are stored in the rear storage box of the MX8 (left). A protective apron is also carried on a hanger from the hook on the support column.

**Wada** If I forget to recharge the main unit battery after multiple emergency examinations, the MX8 has an Auto-Power-Off function that conveniently reduces power consumption from the main unit battery. Other staff members have also mentioned the Inch-Mover buttons make positioning easier, and the responsive exposure switch makes it easier to time image acquisition with maximal inspiration. I have also heard people comment the brightness of the monitor on the main unit makes examining reference images easier, the storage areas for the FPD and small objects are well thought out, and the surface coating and wiring are easy to clean and good for infection control. The collimator on the MX8 is also more compact and has less surface area to be wiped. Plastic bags and cleaning wipes can also be kept in the storage box while on rounds, a particularly useful feature during the COVID-19 pandemic.
